# Conservation and Restoration Guidelines for the *Omo Sebua* in Bawömataluo Village, South Nias, Indonesia

**Keywords:** conservation, repair, guideline, wooden building, *omo sebua*

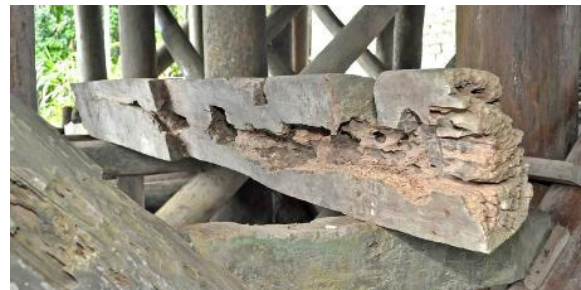
Figure 6. Termite damage

Termite damage in the pillars is significantly serious. Some parts have become hollow, and the surfaces of some pillars have become rutted and uneven due to the termite feeding (Figure 6). In some parts of the short pillars, the termite damage tracks extend until the floor of the main structure, which indicates that the damage has already spread to the living space. In addition, since fresh feces can still be seen around, like grains of sand, we can know that there must be termites still inhabiting inside. Among these pillars, new materials and second-hand components are included, which makes it very difficult to tell which are the original ones from the appearance.

Among these damages, the most destructive ones are termite damage and decay. Although termite damages differentiate from each other depending on the different species of the termites, the most serious damage is made by hollowing a wood structure. In this occasion, most materials have to be totally replaced by new materials. If there is an important component needed to be preserved or a bent beam that cannot be replaced, an appropriate solution is to cut the component in lengthways and bury a new material into it. After that, scientific technologies should be used to join the surfaces of the old materials again. This mending is technically difficult, so it requires a preservation specialist and an epoxy resin specialist to accomplish it together.

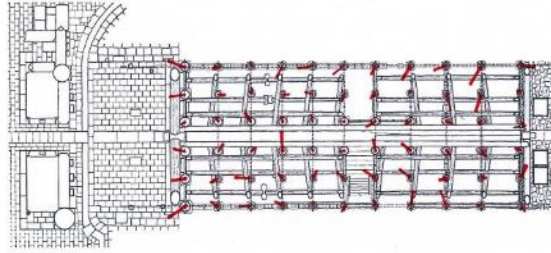
As for the inclination and uneven settlement, the investigation results showed a quite big difference between each pillar. The maximum inclination is 5/100, and the most common inclination is about 2/100, which has

already reached the dismantling restoration level (Figure 7). Especially the short pillars supporting the floor of the main structure incline seriously towards the inner side. It is said that the earthquake caused this inclination, but we believe that the wooden walls resting on the pillars are the main reason for the inclination. According to our investigation in 2011, the number of short pillars that needed to be replaced was 29 (44%), and that of cross pillars was 13 (22%, Figure 8).

Figure 7. The inclination of the pillars (Base map from Inoue's master thesis, 1982)

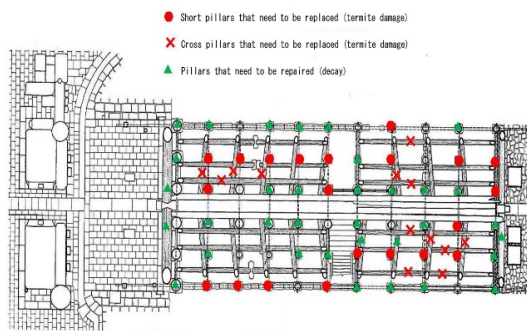
Figure 8. The situation of the substructure in 2011 (Base map from Inoue's master thesis, 1982)

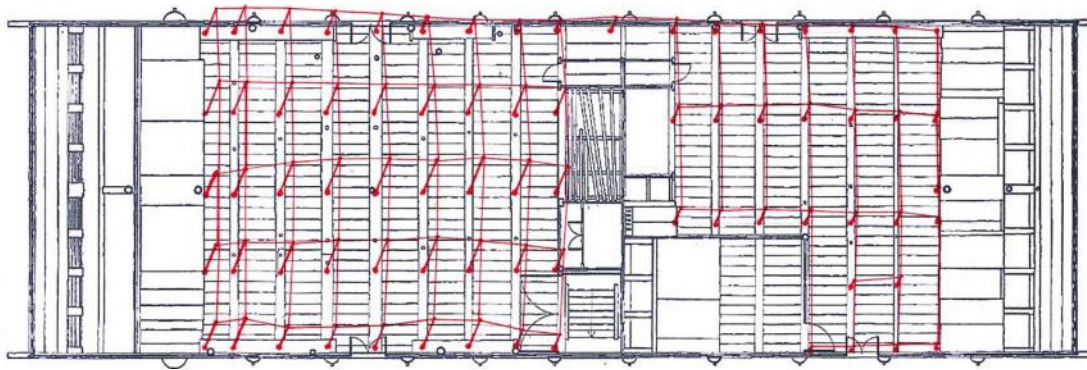
The uneven settlement of the foundation stone is also significant, the most notable sinkage depth reaches 56 cm, and the average sinkage depth is 20~30 cm. The reason for the uneven settlement, according to the interview with the local carpenters, is that the components of the substructure are pretty frequently replaced due to the termite damage. The traditional technology for replacement is to dig out a foundation stone, pull out the corrupted pillar, replace it with a totally new one, and put the foundation stone back (Figure 9). The problem with this method is that it is difficult to set up a pillar vertically, and to put back the foundation stone exactly to the same height. This is probably the reason why the measurement result showed such variability.

Figure 11. The uneven settlement of the second floor (Base map from Inoue' master thesis, 1982)

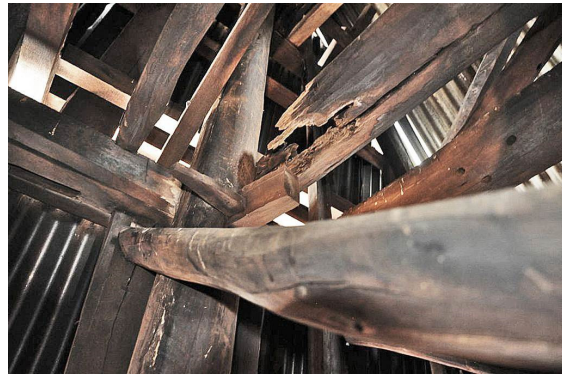
The corruptions of the roof frame concentrate on the gable wall, and they are caused by the rain penetration through the wide gable (Figure 13). Although the gable is covered by sago palm panels, the flashing is not thorough, and, easily damaged. In addition, a part of the sheet-metal roofing has been pried loose by wind, which caused the leakage and brought the corruptions. The other parts of the roof frame are relatively sound, but there is a high possibility that termite damages are occurring in the roof frame above the spacious room, because 3~4 beams have been replaced by new materials.

Figure 13. The corruption of the roof frame

For example, we suggest that the roofing of the *omo sebua* should be rethatched by sago palm leaf. In addition to the authenticity of the building, there is another significant reason for restoring the sago palm leaf roofing. It is that the temperature and humidity change in the roof frame doubles when it is covered by a metal panel instead of sago palm leaf. The dramatic change of temperature and humidity led to the acceleration of the decay of the roof frame (Sadaka, Uekita, T. Hanazato, Nitto, S. Hanazato, Ono and S. Hanazato, 2013; T. Hanazato, Uekita, Ono, Nitto and Oodaira, 2014), so restoring the roofing will help to restrain the decay. However, sago palm tree is not being produced anymore in South Nias because of the changes in the eating and drinking habits of the local people. Therefore, in order to get the roofing materials for the *omo sebua*, sago palm trees need to be planted.
