Agricultural Spray Inspection According to ISO 16122: Part II—Determination of the State of Use and Conservation of Agricultural Sprayers

Keywords: spraying, agricultural machinery, periodic inspection

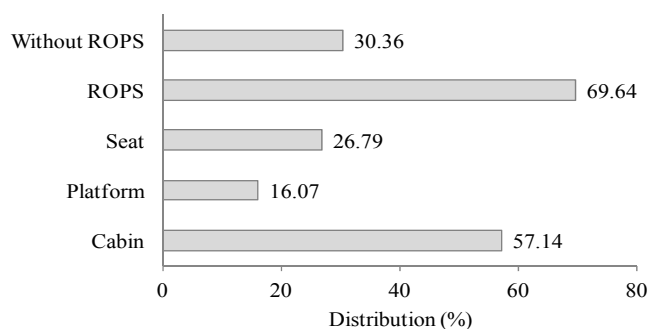
When the item "sprayer operation" was analyzed, the operation position of agricultural tractors and the performance of the activities were evaluated. When analyzing Figure 2, it is possible to notice that 57.14% of the evaluated tractors were equipped with cabins, allowing the operator to have greater protection and safety during the performed activity. In the other evaluated tractors, 26.79% presented the a seat-type operative station and 16.07% were platform-type. However, the item that is worth highlighting is related to the absence of the rollover protection structure (ROPS), which occurred in 30.36% of the tractors, leaving the operator totally unprotected.

Figure 2. Evaluation of the operation station of tractors that composed the mechanized set (tractor + sprayer)
