Indoor Environmental Quality Assessment of Historic Buildings in the State Park: A Case Study in Michigan

Suk-Kyung Kim¹

¹ Interior Design Program, School of Planning, Design, & Construction, Michigan State University, USA

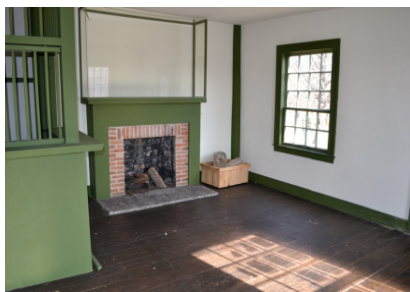
Because ventilation could affect indoor air quality, it was measured. As table 3 presents, the Hewitt House building provided stable levels of ventilation ranging from 15 to 41.4 ppm compared to those in Walker Tavern building that showed a bigger variation range. In the Walker Tavern building, cracks between window frames and walls brought in outside air. The windows were single layers and have not been replaced since the 1960s. This made it difficult to regulate the room temperature and ventilation to provide comfortable indoor environments for visitors. Figures 5 and 6 show these conditions of the rooms in the Walker Tavern building.

Figure 5. Taproom in the Tavern

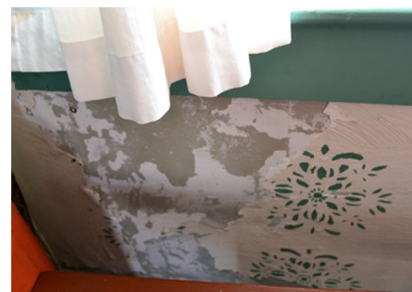
Figure 6. Unfinished wall in the Tavern

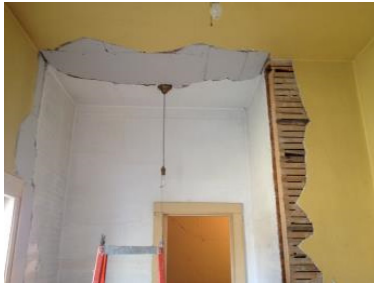
The Hewitt House building had better indoor environments. Yet, its exhibition space had lower temperatures and cold air flows because its outdated ducts and vent systems blocked the flow of warm air. There was either no or very thin insulation inside the walls and attics. Figure 7 through 12 show these problems of the spaces. These problems severely compromised the indoor environmental quality. Therefore, the research team proposed solutions to these problems in its future improvement plan.

Figure 7. Wall and ceiling in the exhibit room corner

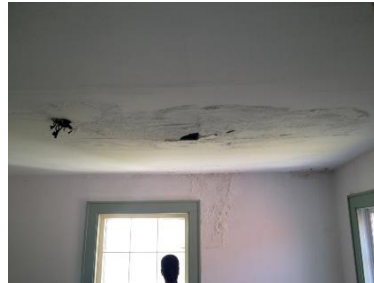
Figure 8. Cracked ceiling in the storage space

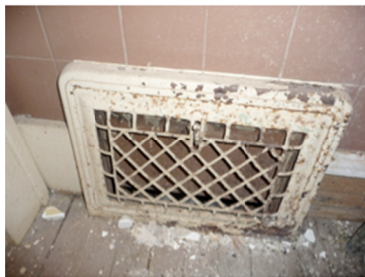
Figure 10. Unmaintained vent to be replaced

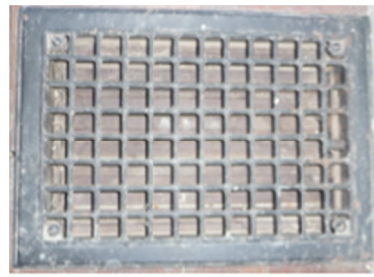
Figure 11. Improperly covered vent

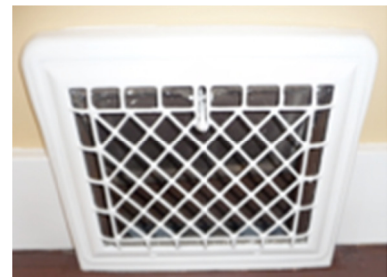
Figure 12. Updated vent

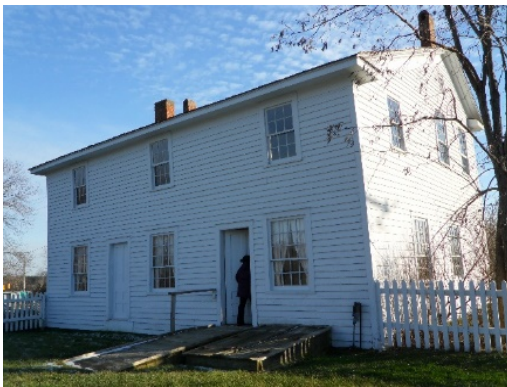
Figure 13. Walker Tavern Building Façade

The orientations of the buildings can affect illumination and temperature controls of the buildings (USGBC, 2011). The main entrance of the target buildings faced south. The longer exterior walls also faced south, which could admit more daylight to the interior spaces. Figures 13 and 14 show the buildings' exteriors that take daylight. The future improvement plan should maximize these advantages.

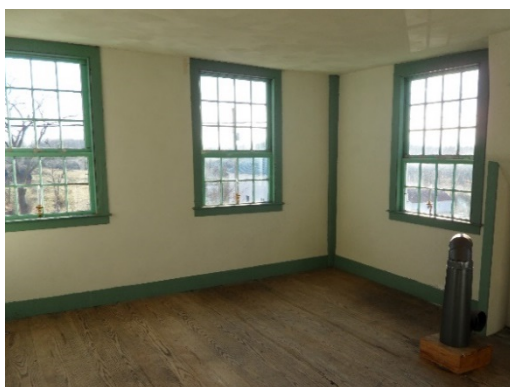
Operable windows can admit fresh air from outside (USGBC, 2011). Operable windows can also help to control indoor temperature and humidity. All windows in the two building were checked to see if they could be opened easily. None of the windows in Walker Tavern building were easy to open. Some were sealed shut. The windows in this building still had their original shapes and finishes. They have not been updated for several decades. Therefore, the windows did not function properly for the purpose of ventilation.

Figure 15. Windows in Walker Tavern Building

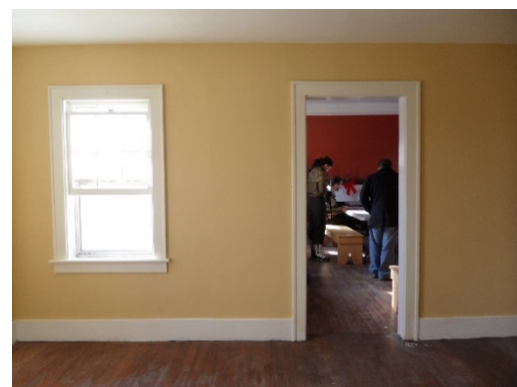
Unlike those in the Walker Tavern building, most of the windows in the Hewitt House building could be opened and closed, but only with difficulty. Some window frames of this building had been repainted or remounted. Therefore, they could be used for ventilation purpose. Yet, the windows needed strong forces to be pushed or pulled to open and close. Figures 15 and 16 show the windows in these two buildings. Although the windows were not easy to use, they still let plenty of daylight into the buildings. This natural light improved the indoor environmental quality of the buildings.

Figure 16. Window in Hewitt House Building
