# An Analysis of Dampness Study on Heritage Building: A Case Study Ipoh Old Post Office Building and Suluh Budiman Building, UPSI, Perak, Malaysia

**Keywords:** Ipoh old post office building, Suluh Budiman building, Dampness analysis, Heritage building and conservation works

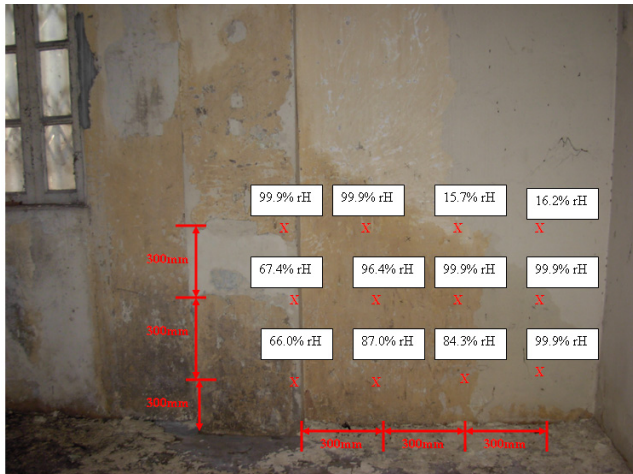
Rising damp occurs as a result of capillary suction of moisture from the ground into porous masonry building materials such as stone, brick, earth and mortar. The moisture evaporates from either face of the wall (inside or outside), allowing more to be drawn from below. The height to which the moisture will rise is determined by the evaporation rate and the nature of the wall. The normal limit for rising damp ranges from 0.5 to 1.5 meters above ground level. Rising damp may show as a high-tide-like stain on wallpaper and other interior finishes, and, when it is severe, as blistering of paint and loss of plaster. Damp walls encourage the growth of moulds, which, with high humidity, can lead to health problems to occupants. Externally, a damp zone may be evident at the base of walls, with associated fretting and crumbling of the masonry. On its own, rising damp can make buildings unsightly and unpleasant to occupy. The situation is much worse if there are appreciable quantities of soluble salts present, for the rising damp will carry salts up into the masonry to where the damp evaporates. Then, the salts are left behind and can often be seen as a white efflorescence on the wall surface. When these salts grow as crystals within the pores of the masonry they can disrupt even the strongest material, leading to fretting and crumbling of the surface. This process is known as salt attack, and, when it is severe, it can lead to slow but complete loss of stones and bricks in a wall. For this building, rising damp occurs at internal and external wall which are 16 identified areas for internal wall while 6 areas for external wall. Photo 4.1 and Photo 4.2 below show the symptoms of rising damp at this building while Table 4 shows the affected location. < **Table 4.1: Location of Rising Damp** >

Grid: B/7-8 (X12), Checklist 12  
Photo 4.1 Symptom of Rising Damp

Overall condition of internal wall for ground floor level experience rising damp. The properties of salt can penetrate water that can cause water movement from bottom of wall to top level of wall. For this building, the preferment of water is between 1.2 m until 1.5 m from the bottom of wall. Water movement penetrated to the most salty area of the wall. The recommendation to overcome rising damp matter is by using 'Chemical Dampproof System Technique' and 'Cocoon' techniques. For cocoon technique, the paste must bond properly to the surface to be treated. Thus, the surface must be sound and swept clean of salt, dust, sand or loose fragments. Special precaution is to be taken where the surface is delicate and/or easily detached. After that, the material applied to the bricks surface to be desalinated as poultice is 5 mm to 10 mm thick according to the type of the surface by means of a spatula or by spraying. The quantity recommended is normally 6 to 7 kg of wet materials per square metre. The poultice is left to perform its action for about 2 weeks. After drying, the paste becomes cardboard mould which can be peeled off from substrate and disposed of. After that, the technique will be continued by using 'Chemical Dampproof Course System' technique. On the commencement of a typical rising damp project, the applicator removes the original skirting. Skirting may be refitted after the installation of the chemical damp proof course and the completion of the replastering. In some cases the skirting may be rotten and require replacement. The damp effected plaster is then removed to expose the bricks. After selecting the course of the brick which will become the new damp proof course, a series of 10 mm holes are drilled at an appropriate depth and spacing. The injection lances are then introduced into the holes and a seal is formed by a rubber expansion washer which holds the lance firmly into the brick. The injection fluid is then pumped via flexible tubing into the brick work and the fluid, now under pressure, is forced through the capillaries of the brick until it is visually evident that saturation has taken place. The lances are then removed and the procedure is repeatedly progressing along the wall to be treated. The injection fluid continues to penetrate through mortars joints by capillary for approximately 24 hours. After the full thickness of the wall is injected the continuous saturated section of brick will become the new damp proof course. After a short drying period the walls may be replastered to complete the job.

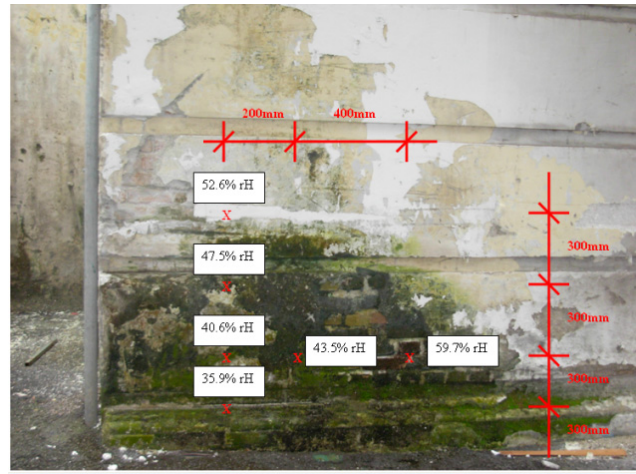
Grid: C-D/3-4 (Y9), Checklist 25  
Photo 4.2 Wall Attacked by Fungus

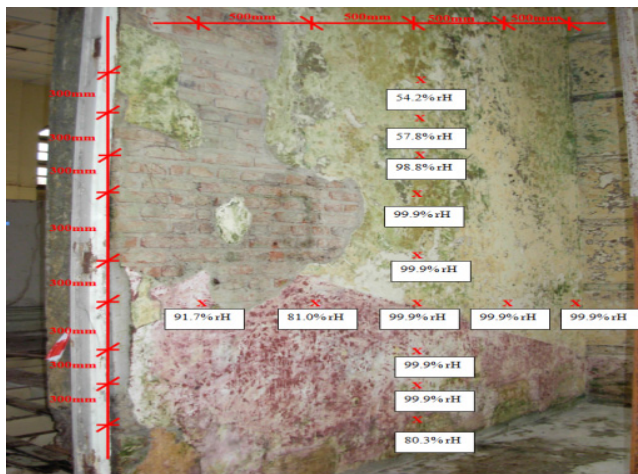
Roof structure experiences the most serious defect. Roof covering is broken and had caused the building to be exposed to the rain and sunlight. Wood structure decayed and faces termite attack seriously. Besides, the bonding between lime plaster and surface of bricks became weak because of long exposure of dampness. The surface was brittle, flaking and blistering. On the other hand, the wall is also affected by mould and fungus attack, these can be seen at 8 locations selected by the contractor at the first level. The reading of moisture meter showed the aptly frequency which is the wall below is higher than the above wall. Photo 4.3 and Photo 4.4 show several locations experience the same defect while Table 5 below shows the defected location. < **Table 4.2: Location of Roof Leakage** >

Grid: G/7-8 (X1), Checklist 33  
Photo 4.3 Fungus and Mould Attack

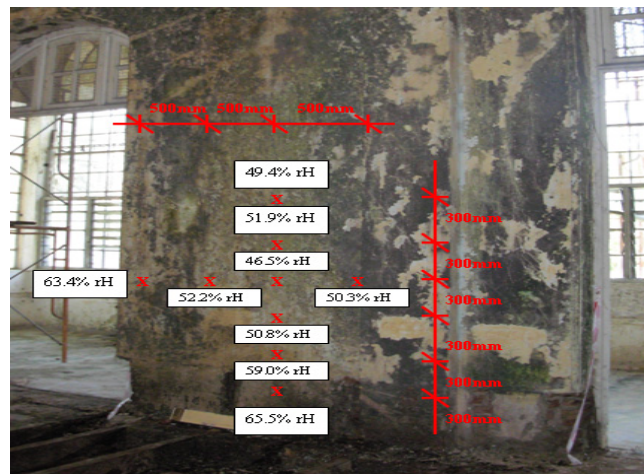
Grid: G/5-6 (Y2), Checklist 36  
Photo 4.4 Wall Wet and Damp

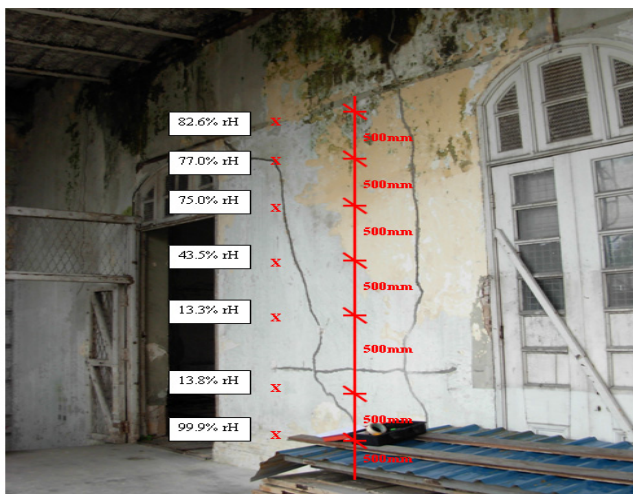
There are hairline crack occurs on wall lime plaster which means the existence of capillary effects that cause water penetration into building wall. In this study, there are three (3) locations of plaster crack. Photo 4.5 and Photo 4.6 show the plaster cracks occur on wall and Table 4.3 below shows affected locations. < **Table 4.3: Location of Plaster Crack** >

Grid: B/7-8 (Y3), Checklist 37  
Photo 4.5 Minor Cracks Along Wall Plaster

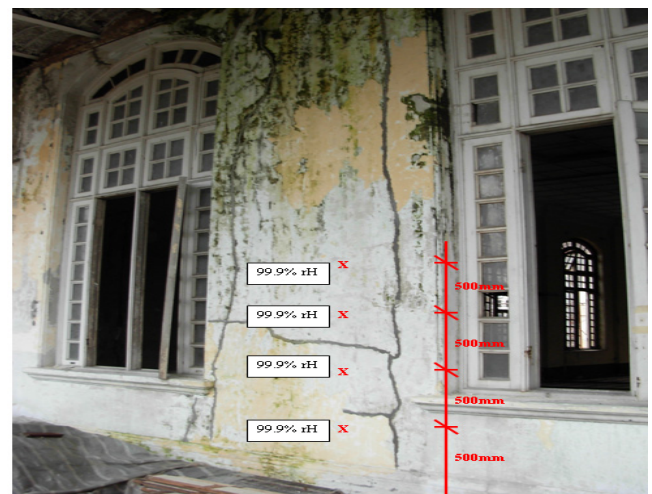
Grid: B/9-10 (Y4), Checklist 38  
Photo 4.6 Vertical Cracks

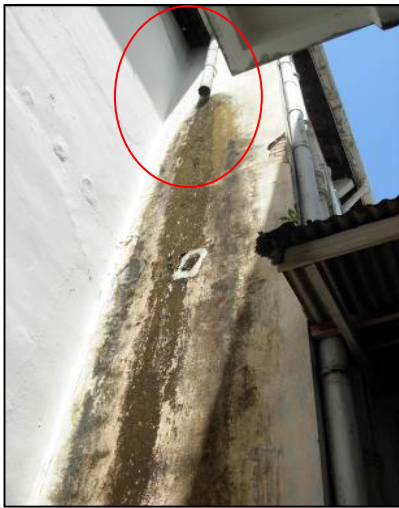
Grid: E/4 (Y6), Checklist 22

Rainwater goods such as rainwater down pipes are not functioning properly. Most of the rainwater goods are broken, decayed, corroded and damaged so badly. This situation will cause inappropriate water flow and the surface of the wall and floor are highly moisture and attacked by fungus. The inappropriate water flow leads to the crack of parameter drain. In this study, there are six (6) identified locations effected by defective rainwater goods. Photo 4.7 and Photo 4.8 show several problems occurred caused by design deficiency of rainwater down pipes and Table 7 shows overall area defected by the same causes. < **Table 4.4: Location of Defective Rainwater Goods (RWDP)** >

Photo 4.7 Inefficient of RWDP Effect

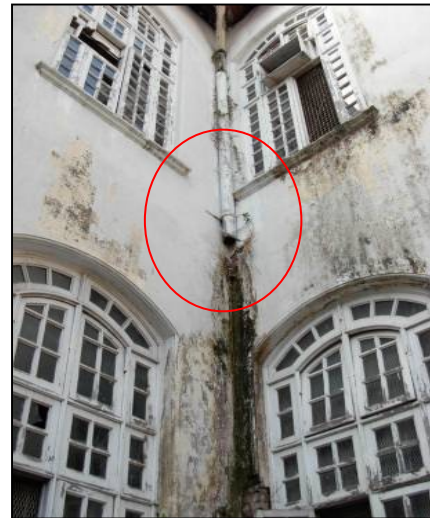
Grid: D/8 (Y3), Checklist 19

Photo 4.8 Fungus Attack

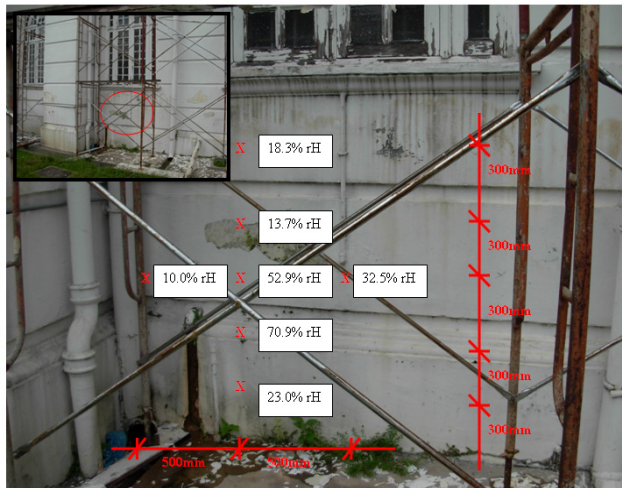
Grid: B/2 (Y10), Checklist 26

The leakage of clean water supply pipe that has been buried inside the building components also happened in this case study. There is only one (1) location affected which is at grid: B/2 (Y10) where the water was easily flowing at the buried pipe. The moisture meter showed the increasing reading close to the location of dampness which is 70.9%rH. Photo 4.9 shows the defected location.

Photo 4.9 Location of Pipe Leakage

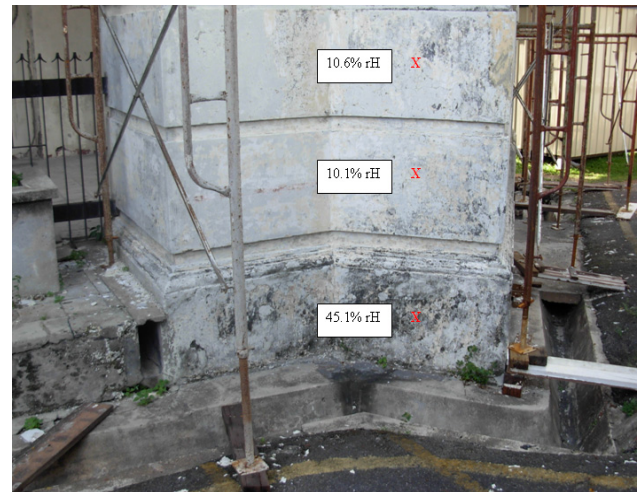
Grid: G/12 (TL4), Checklist 31

Driving rain always occurs at the exposure area, the effect of driving rain will cause high level of dampness at a wall. The material of wall is derived from lime and bricks. The property of lime such as porous will lead to penetration of rain water and from the environment. For this building, three (3) locations have been identified caused by driving rain. Photo 4.10 shows the defected area and symptom and table 9 shows the overall defected locations. < **Table 4.5: Location of Driving Rain** >

Photo 4.10 Location of Driving Rain

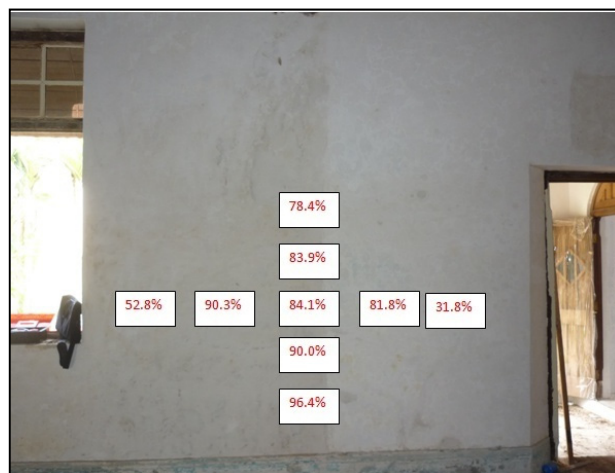
Moisture problem in Suluh Budiman Building is caused by several factors such as roof leaking and the driving rain from defective rainwater goods. There are Four (4) high moisture reading identified locations. First location is at internal wall, the dampness can be seen from the symptom itself such as humid, paint blistering and chipping while the lime plaster crumbled. The temperature is about 29°C. The causes of defect are leaked roof structure, broken roof tile and defective rainwater goods. Photo 5.1 below shows high reading of moisture meter at internal wall.

Photo 5.1 Dampness at Internal Wall Caused by Roof Leakage

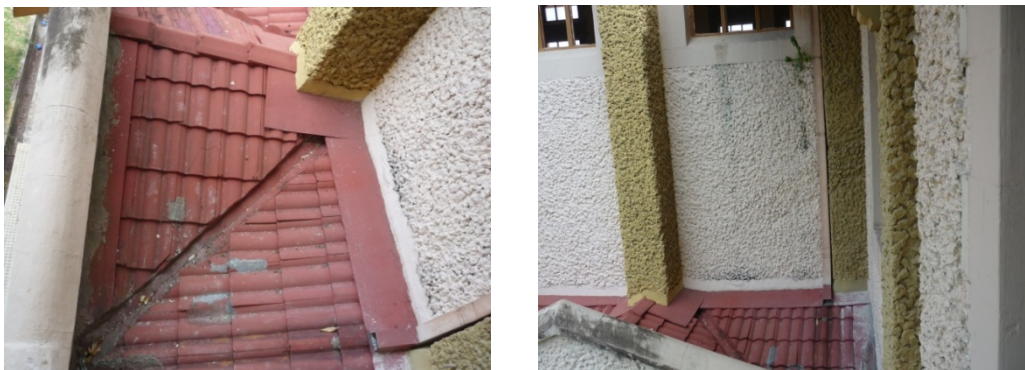
From the above reading of moisture meter, the highest moisture content is 96.4% rH, the dampness can be detected from top to bottom. Photos 5.2 below show the several causes that contributed to wall dampness.

Photos 5.2 Defective Rainwater Goods

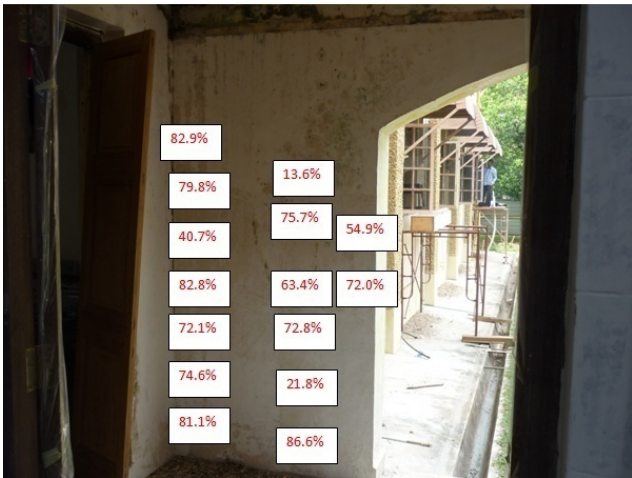
Internal wall near to the arch also experience the same defects. The surface of wall was partially covered by moss and fungus while another defect is paint flaking. This matter happen because of water from top had penetrated into mortar joint and ceiling to cause ceiling decay. Refer Photo 5.3

Photo 5.3 High Moisture Content Caused By Water Penetration

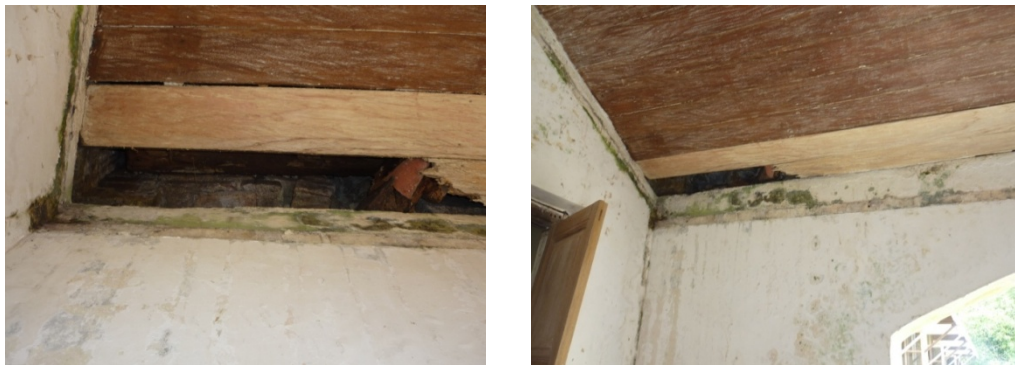
From the above reading of moisture meter, the highest moisture content is 86.6% rH. The dampness can be detected from roof. Photo 5.4 below shows the several causes that contributed to wall dampness and its effects.

Photos 5.4 Moss, Fungus and Ceiling Decay

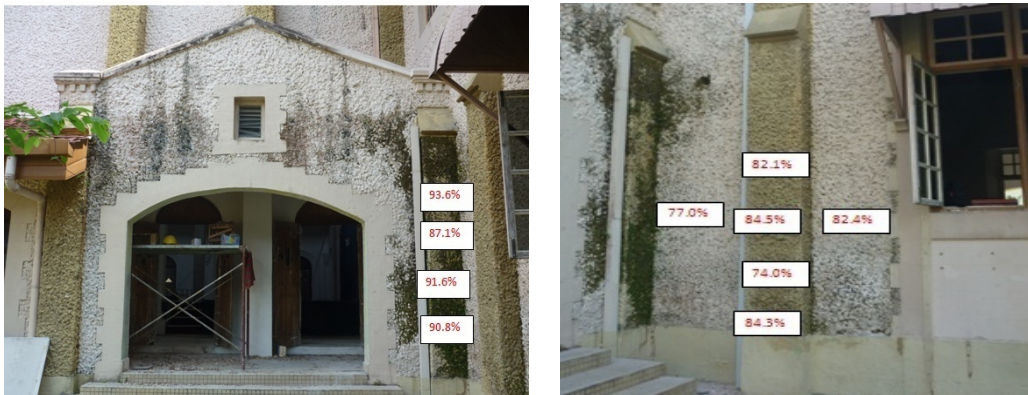
Next location is at external wall, unwanted plant such as ficus and fungus attacked the surface of column and wall. This matter happened because of design deficiency of rainwater goods. Refer Photos 5.5

Photos 5.5 Moss and Black Staining Occur on the Surface of Wall

From the above reading of moisture meter, the highest moisture content is 91.6% rH. The dampness can be detected from roof structure. The best way to overcome this problem is by doing repair work of rainwater pipes and planned maintenance must be done after conservation works completed.

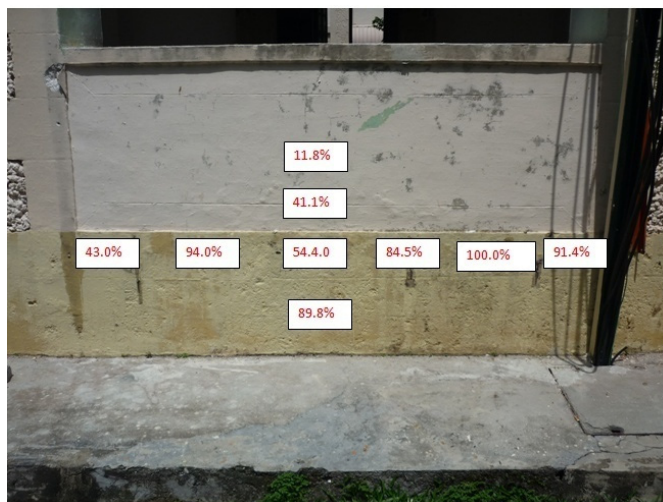
The last location of dampness is situated at external wall at rear side of the building. The defect of the wall is caused by rising damp, the crack at the drainage parameter and apron contributed to moisture penetration. The height of rising damp is about 800mm. Photo 5.6 below show the reading of moisture meter.

Photo 5.6 Rising Damp

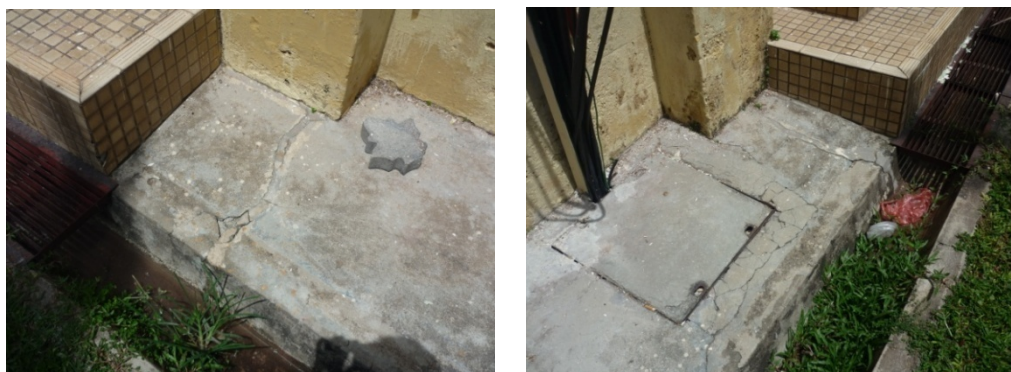
From the above reading of moisture meter, the highest moisture content is 100% rH. The moisture had caused

high dampness on wall, paint blistering, broken drainage and cracking at apron. Photos below show the symptoms of moisture penetration through wall and its effects. Refer photos 5.7

Photos 5.7 Broken Drainage and Cracking at Apron

- 3) Repair drains parameter system and apron. Main task is to remove the precipitation such as mud, plant and rubbish which contribute to blockade in drain parameter.

- 4) Knock cracked surface and restore apron such as original shape.
- 5) Replace the broken and cracked drain with new drain and corresponding drainage system.

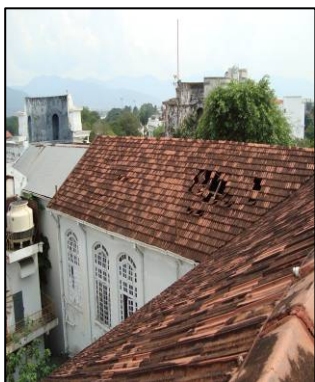
- i. There are several locations experiencing rising damp problem
- ii. Design deficiency of rainwater down pipe
- iii. Roof covering ruined and leakage: Refer to Photo 6.1
- iv. Not enough projection of roof structure to avoid heavy driving rain, Refer to Photo 6.2
- v. Too much exposure from the weather such as direct sunlight and rain and the failure design of roof. Refer to Photo 6.3
- vi. The arrangement of roof tile is not properly done and rain water easily penetrates into the building. Refer to Photo 6.4
- vii. Parameter drain was badly damaged due to settlement and caused the water to easily penetrate under the floor and it makes the sand bed removed from its place. Refer to Photo 6.5 and Photo 6.6.

- i. Repair and redesign the new rain water down pipe as well as gutter system. It must be functioning well with maintenance prediction and try to avoid the increasing of maintenance cost.
- ii. Redesign the projection of roof structure to reduce driving rain's effects and direct sunlight.
- iii. Some locations with high level of dampness require 'Chemical Dampproof System Technique' and 'Cocoon' techniques.
- iv. Replace and rearrange the roof tiles.

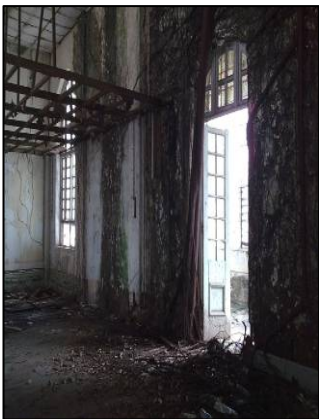
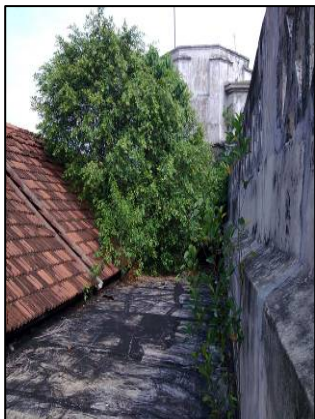
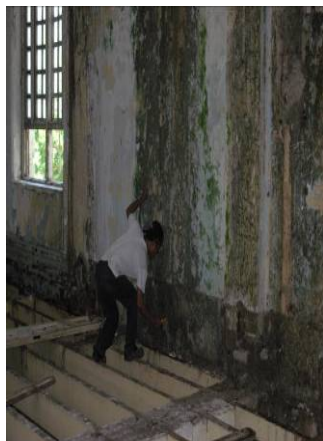
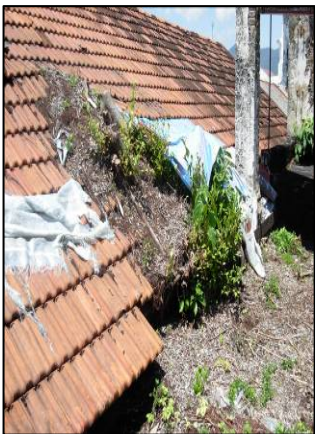
- ii. Photo 6.7 and Photo 6.8 show a tree grew before it was trimmed. While Photo 6.9 and Photo 6.10 show the condition after the tree was trimmed. That situation had lead to the highest level of dampness in this building.
- iii. There are hairlines cracks occur in the wall that lead to the water penetration by water movement in the capillaries. Refer to Photo 6.11
- iv. Minor cracks on the floor can be seen from the flat roof that acts as a floor balcony on the top floor. Refer to Photo 6.12.
