The Children's Playgrounds in Apartments and Terrace Housing Areas: Places of Leisure or Failure?

Abstract

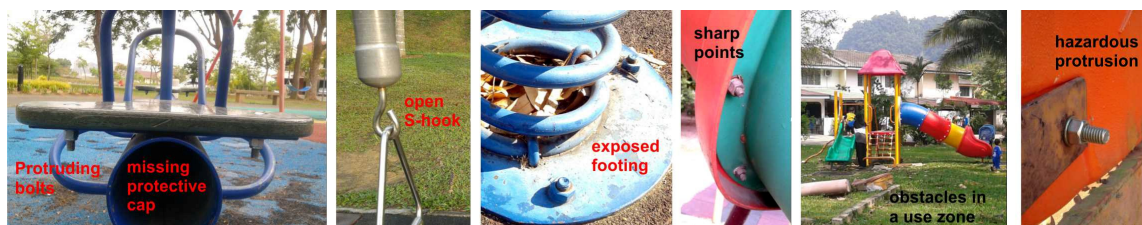
Figure 4. Examples of observations detecting general hazards

Only 12% of the entire playgrounds convinced satisfactory in the evaluation of safety for general hazards. These mean, other 50 playgrounds were potentially unsafe and if the study was to look into a bigger scale, the unsafe playgrounds pertaining to general hazards would become far too obvious. Probably, the playgrounds that our kids are playing right now are silently alarming with these issues; yet the equipment is still played by children, and added by the ignorance of their parents' hope that nothing will happen, even though the potential hazards are within a striking distance from biting their children. Equipment was deemed to be the most unsafe (Macpherson et al., 2010). A missing bolt and an end-cap, for example, was thought of being able to be repaired, instead it was retrofitted and left to be an obvious hazardous protrusion.

The problem cases were summarized in the Figure 4. In developed countries, where safety measures were strictly implemented or as followed by the guide from the Handbook for Public Playground Safety (CPSC, 2010), for example, these scenes were surely the taboos. Many factors appeared to have been taken for granted in the issue of general hazards. From observations, the researchers had learnt that the inaccurate practices were accepted in the local business for long. Presumably, the lack of guidance and safety acts were the probabilities that helped this issue to arise, but passively unnoticed by the local authorities until it was proven to cause severe accidents on the playgrounds, only then, the respective bodies would normally start to talk about preventive maintenance. Small defects could be the likelihood for accidents yet a small event of accidents or mishaps sustained by the children were only taken as notions of childhood.

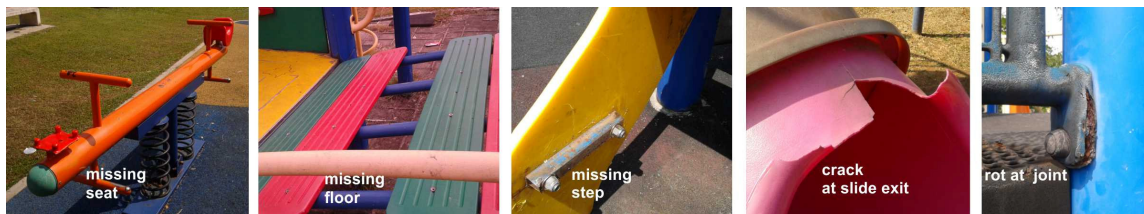
Figure 5. Examples of observations detecting durability problems

The study had recorded 39% failures under the equipment durability checklist. Durability defects were detected in the form of rust, rot, crack, splinters, and signs of broken and missing components (Figure 5). To ensure good conditions, all playground equipment must be free from any malfunction and deficiency. Only new playgrounds were beautiful, safe and could be offered with adequate safety protections. Aging playgrounds or after three to five years in service; the durability conditions on the playgrounds were shameful. Small defects and deficiencies were mostly left unrepaired. The researchers were afraid that if the worsening playgrounds weren't provided with appropriate maintenance programmes, those playgrounds would become the public nuisance. There were a few horrible playgrounds that should better be demolished because of the intense broken equipment and missing components which had made them unplayable (Figure 6).

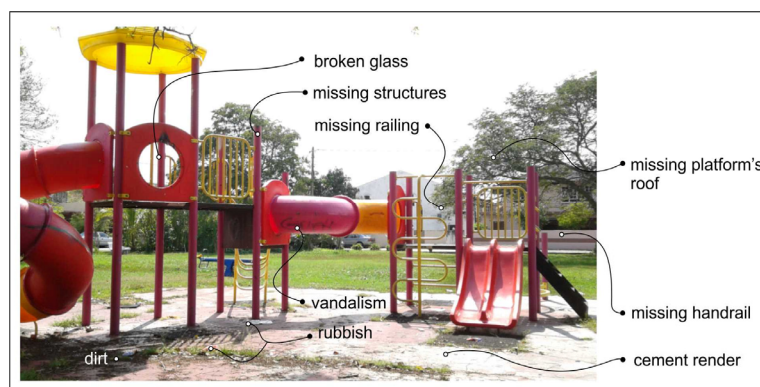
Figure 6. An example of a horrible playground at Selasar Rokam terrace housing area, Ipoh

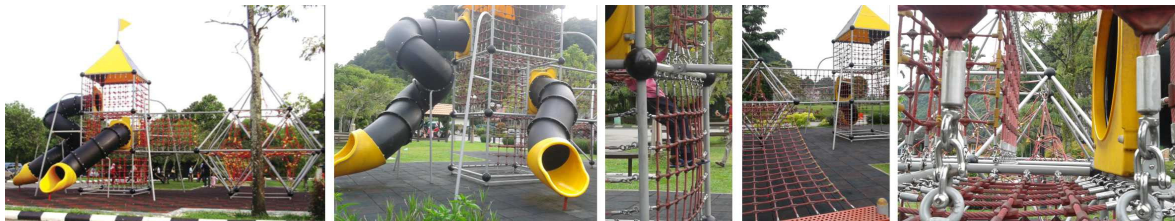
The integrated unit or the composite-play structure (CPS) was contemporary in the modern playgrounds nowadays. In a prime recreational area, a playground park would have consisted more than one CPS on their site. Equipment for younger and older children was grouped together and there was no notification on the equipment about what age group they were produced for. The element of segregation was studied by Uskun et al. (2008). Yearly & Berlinski (2008) had also proposed the same method, so that the toddlers would be discouraged from using the equipment not designed for them. Besides segregating the CPS functionally based on age-appropriate design, their designs were sometimes very confusing. A child of four years old (and so did his parents) did not know which equipment should his child plays. There was a situation (Figure 7), whereby a group of youth tried their skills on the CPS, because they thought that the 'adventure playground' was meant for them.

Figure 7. A composite-play structure (CPS) in Gunung Lang, Ipoh that was neither suitable for toddler nor junior children

Three of the lowest scored playgrounds fell under the shameful conditions. They were looking like abandoned playgrounds with plenty of deteriorated structures (Figure 7). Those playgrounds could become the danger zones for the public. Presumably, rectification works were in the process, they were left with nothing instead. There should be a notification or at least barricaded by the local authority from causing opportunity of hazards.

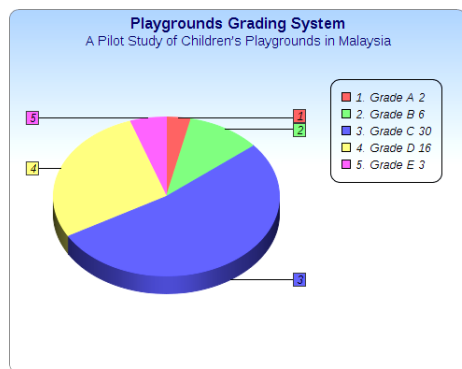
Figure 8A. Playground's grading

The failure for at least one category of the assessment had brought thirty playgrounds and made them able to get only the ‘C’ grades (Figure 8A), or slightly more than a half of the sampling population has to be rated only as the average playgrounds. Precognition in this study, if there were still without adequate measures of playground maintenance, the number of failure playgrounds will be increased and so does the playground accidents.

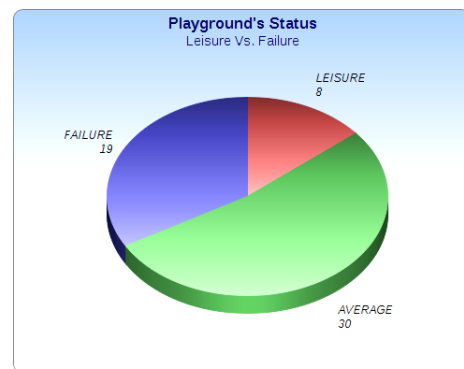
Figure 8B. Playground's status

This study could not apply the overall grading system that was recommended by the NPPS (2006) due to the non-compliance safety standard and non-standardized equipment. However, after a minor modification on the rubric, the surveyed playgrounds were able to be graded into five classifications (Figure 8A). Astonishingly, only two playgrounds, each were situated in Ipoh and Putrajaya, managed to achieve the excellent “A” grades while another six considered as newly completed playgrounds achieved the “B” grades. These eight playgrounds had answered the research aims at finding the ‘leisure’ playgrounds that satisfactorily safe and recommended for all children (Figure 8B).

Two failures in the category of fall surfacing, general hazards or durability of equipment had brought sixteen playgrounds and classified them as ‘D’ grades. The combination of ‘D and E’ grades had made up a total of 19 unsuccessful playgrounds. Therefore, almost one-third of the studied playgrounds population was deemed as the ‘failure’ in playground safety (Figure 8B).

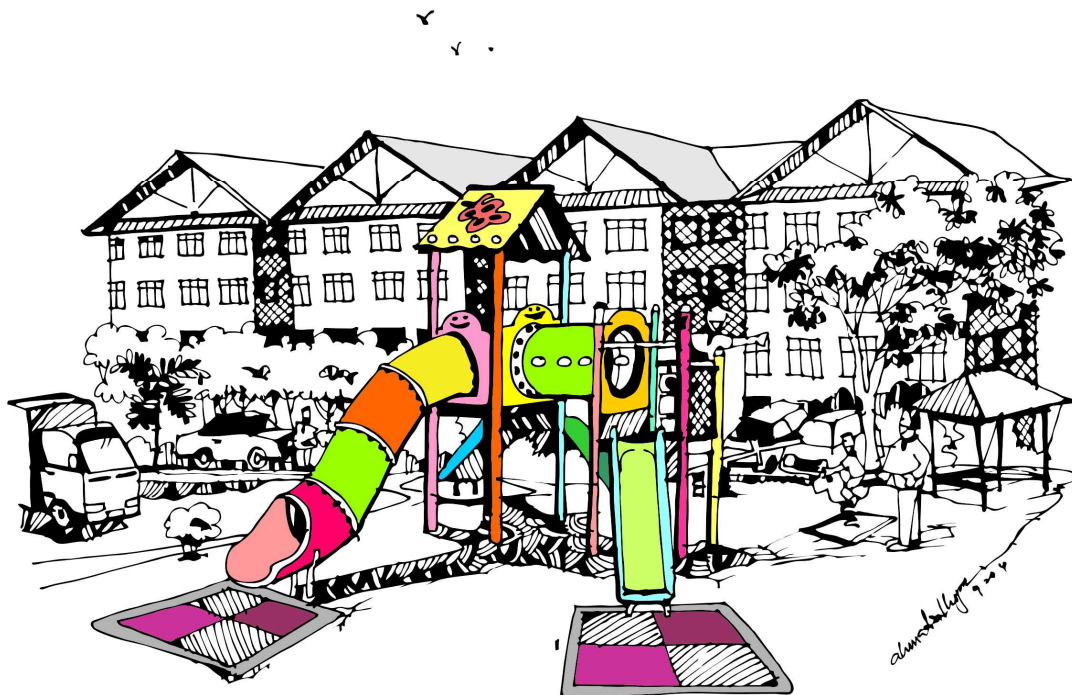
Figure 9. An observational sketch by the researcher of an apartment's playground at Suka Menanti, Alor Setar

A children's playground is a positive presentation for any housing areas. It will be a good focal point, as well as to enhance the 'leisure ambience' for the whole residential area (Figure 9). The researchers had observed many new playgrounds; most of them were left forgotten soon after their projects were completed. That was how the story of failure had begun. Those playgrounds were assumed to be the entities of maintenance-free.
