Some Adaptations to Sea Level Rise in the Coastal City of Limbe, Cameroon

Abstract

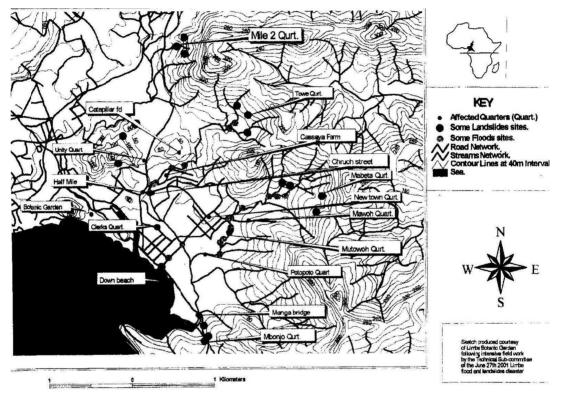
Figure 1. The Delineation of the Limbe High Risk Zones

The geology and geomorphology of the Limbe Coastline calls for concern in so far as its stability for human settlement and the establishment of urban coastal infrastructures are concerned. This is so because Limbe (Fig 1) is a coastal mobile tectonic city which is prone to seismicity. It lies at the foot of the Mount Cameroon strato volcano. So, lithologically, it is composed of basaltic rocks which are blanketed by scoriaceous deposits having

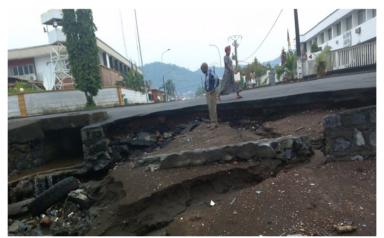
Figure 2. Marine Erosion of the Coastal Highway around BEAC, Down Beach Limbe. Part of the tarred road has collapsed under the impact of the rising sea level

Along this coastal area particularly around Mars Restaurant in the Down Beach coastal area there is a promontory of massive basalts which break and minimise the effects of wave erosion of the man-made coastal structures. This extrusion of massive volcanic rocks and their protective effects teaches us that the coastal stretch from the Ministry of Water and Energy to the Down Beach area could adequately be protected from the constant degradation effects of wave erosion through marine transgression (Figure 2).

In much the same way, the Down Beach coastline has often come under periodic marine erosion that provokes the extensive failures and collapse of the built-up coastline (Table 1 & Fig 3 & 4). Way back in 2001 when Limbe suffered from excessive floods and landslides originating from the Mabeta Hills, sea incursion left an indelible effect of coastal erosion that ate deep into part of the Down Beach road around BEAC Bank (Figure 2) (Ayonghe, et al. 2002).

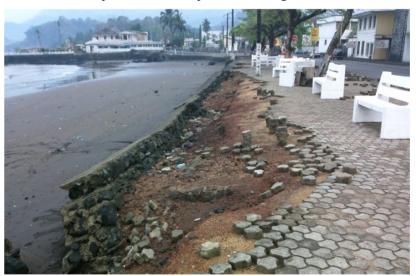
Figure 3. Sea Level Rise and Coastal Erosion of Built-Up Recreational Terraces in Down Beach Coastal Neighbourhood, Limbe

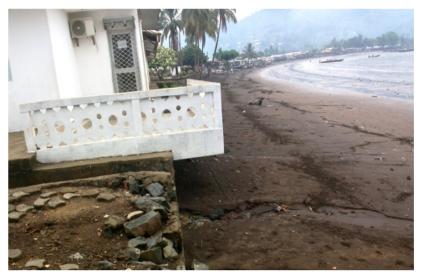
Figure 4. Rising Sea Level and the undermining of built-up structures along the Down Beach Coastline in Limbe

The built-up coastland remains an inadequate strategy in solving the problem of coastal erosion arising from sea level rise. In order to stabilise the coastline along this rapidly degrading zone would require an excavation of the coastline right down to the unweathered bedrock, followed by concreting to prevent the further incursion of waves. These protective structures for now have no concrete reinforcements. All that is done is stone masonry works for aesthetic purposes without the necessary supporting capacity whereas these protective structures should be designed to have reinforced concrete that could stand the test of time.

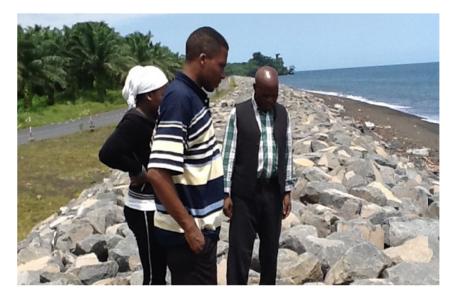
Figure 5. Ripraps which are boulder accumulations have been used along the Limbe Coastline against Coastal Marine Erosion originating from sea level rise

the sea. Consequently, the Dutch jokingly say that "God made the world, but the Dutch made the Netherlands" (Kolbert, 2006). These are a people who live with water. Hence, coastal stabilisation is not a new phenomenon. In like manner, we could build extensive bulwarks of coastal defences composed of man-made dykes of concrete caissons with rock boulders or ripraps and dunes dropped at the foot of the caissons for reinforcement. Behind the concrete structures landwards, the aesthetic pavements could then be put in place as their stability is ensured. Such a rock-buttressed dam-like structure has today been used along the West Coast of Cameroon (Figure 5).

With the rising sea level today and its erosive impacts on the coastline and other human infrastructures, it becomes necessary for us to invoke the use of ripraps which have been used with considerable success along some parts of the Limbe coastline where sea incursions were threatening some piece of the Limbe-Idenau Highway which runs along the coastal lowlands very close to the sea.
