An Assessment and Mapping of Gully Erosion Hazards in Abia State: A GIS Approach

Abstract

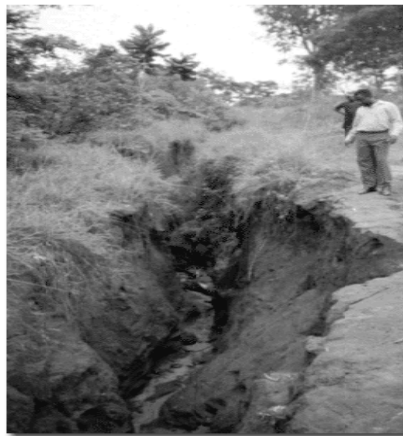
Figure 1.1 The expansion of gully erosion along foot path near farmland

Figure 1.1: The expansion of gully erosion along foot path near farmland.

In spite of technological advancement, erosion menace still remains a major problem in Nigeria (especially in South Eastern Nigeria). The yearly heavy rainfall has very adverse impacts altering existing landscape and forms. Such landforms create deep gullies that cut into the soil. The gullies spread and grow until the soil is removed from the sloping ground. Gullies when formed expand rapidly coupled with exceptional storm or torrential rain down the stream by head ward erosion gulping up arable lands, economic trees, homes, lives, sacking of families (Umudu, 2008) and valuable properties that are worth millions of naira. As a matter of fact, there is a direct correlation between development and the effect of gully erosion in Abia State. Figure 1.1 shows a typical erosion site.

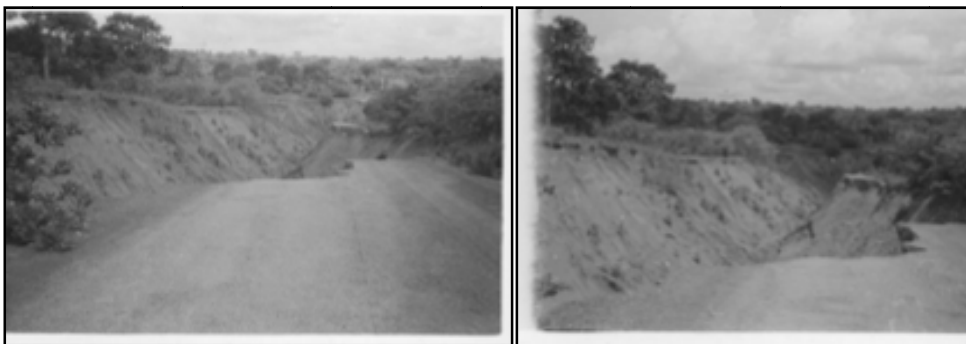
Figure 1.2 Eroded sites in Amaokwe Community, Abia State

Figure 1.2: Eroded sites in Amaokwe Community, Abia State.

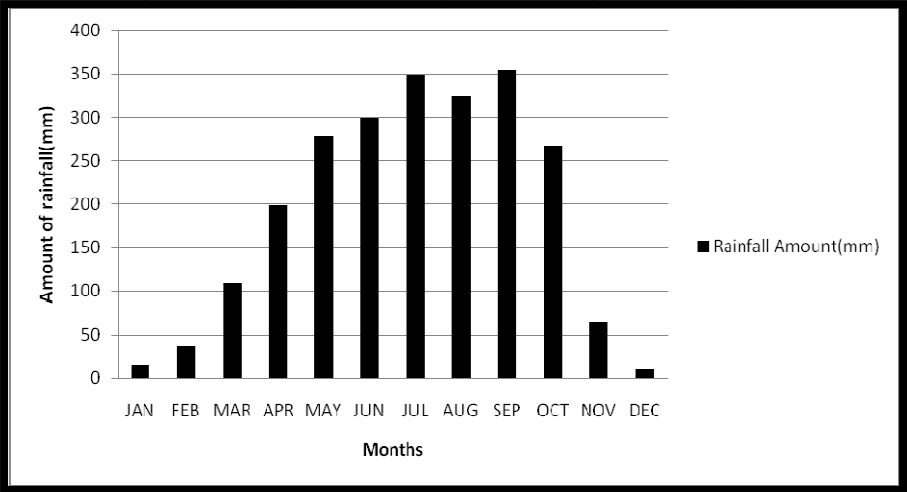
Figure 1.6. Mean distribution of Rainfall from 1972-2010

Abia experiences a high rainfall with corresponding high discharge of water as runoff that encourages gully erosion. It has a peak period between July and September (Figure 1.6). In a study conducted by Jimoh (2005), rainfall events were found to be highly correlated to erosion in all the representative land surface types.

Figure 1.6:- Mean distribution of Rainfall from 1972-2010

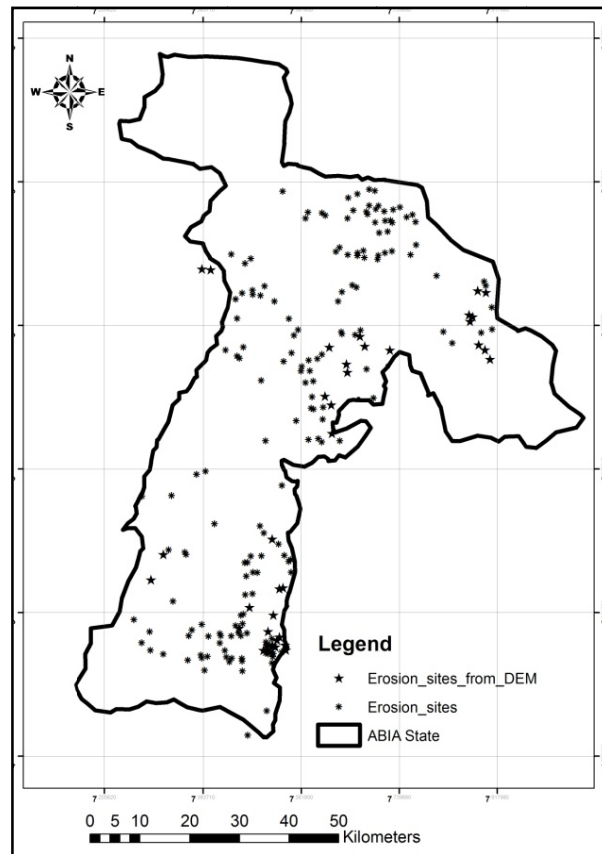
Figure 4.1 Gully Erosion Sites in Abia State

The application of GIS in gully erosion study cannot be over emphasized. One hundred and seventy one gully erosion sites were identified in Abia State and coordinated during field work. From the processed ASTER data, thirty five additional gully erosion sites were located (Figure.4.1). Further verification (ground truthing) confirms that those points were actually gully erosion sites.

Figure 4.1: Gully Erosion Sites in Abia State
