# Conservation and Restoration Guidelines for the *Omo Sebua* in Bawömataluo Village, South Nias, Indonesia

**Keywords:** conservation, repair, guideline, wooden building, *omo sebua*

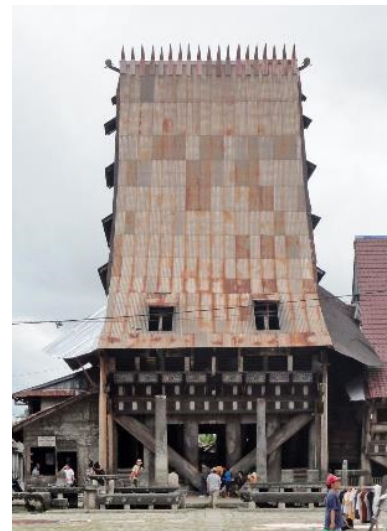
Figure 4. Omo Sebua

The *omo sebua* consists of a substructure, main structure (living space) and roof frame (Figure 4). The substructure is made up of an interwoven pattern of longitudinal and transverse pillars, which has a proven earthquake resistance (Gruber and Herbig, 2005). Above the substructure is the living space, and side wall panels, connected by beams, stands on both sides. The roof frame is composed by heavy crossbeams and struts, which raises the roof very high. In addition, the roof is now covered by zinc, while it used to be covered by sago palm leaf.

On March 28, 2005, a massive earthquake occurred 90 km to the south of Sinabang at a magnitude of 8.7. Although no buildings collapsed at the Bawömataluo village, some pillars of the *omo sebua* slanted, and subsidence can be seen in several parts of the floor (S. Hanazato, T. Hanazato, Uekita, Ono, Nitto, & Oodaira, 2014).

As mentioned above, the *omo sebua* has shown significant age-related deteriorations and earthquake-related damages. In order to conserve the building in a good physical condition in the future, it is considered that a dismantle restoration is needed.

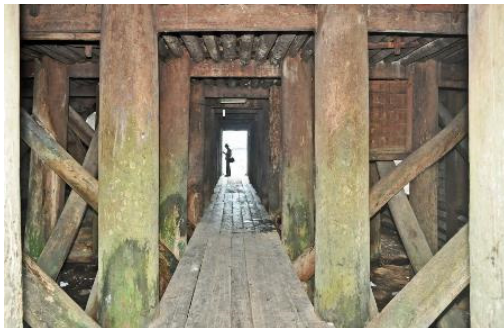
Figure 5. Substructure

The substructure consists of 66 short pillars and 43 cross pillars. The short pillars are 38-68 cm in diameter and about 3.8 meter in length, and they are lined in 6 columns in the trabecular direction and 11 rows in the spanwise direction. The cross pillars arranged in a crisscross pattern are 35-67 cm in diameter and about 6.5 meter in length (Nitto, Uekita, T. Hanazato, Ono and S. Hanazato, 2012, Figure 5). Deteriorations caused by humidity can be often seen both in the short pillars and cross pillars, the number of which that need to be replaced is 20 and 13, respectively.

already reached the dismantling restoration level (Figure 7). Especially the short pillars supporting the floor of the main structure incline seriously towards the inner side. It is said that the earthquake caused this inclination, but we believe that the wooden walls resting on the pillars are the main reason for the inclination. According to our investigation in 2011, the number of short pillars that needed to be replaced was 29 (44%), and that of cross pillars was 13 (22%, Figure 8).

The uneven settlement of the foundation stone is also significant, the most notable sinkage depth reaches 56 cm, and the average sinkage depth is 20~30 cm. The reason for the uneven settlement, according to the interview with the local carpenters, is that the components of the substructure are pretty frequently replaced due to the termite damage. The traditional technology for replacement is to dig out a foundation stone, pull out the corrupted pillar, replace it with a totally new one, and put the foundation stone back (Figure 9). The problem with this method is that it is difficult to set up a pillar vertically, and to put back the foundation stone exactly to the same height. This is probably the reason why the measurement result showed such variability.

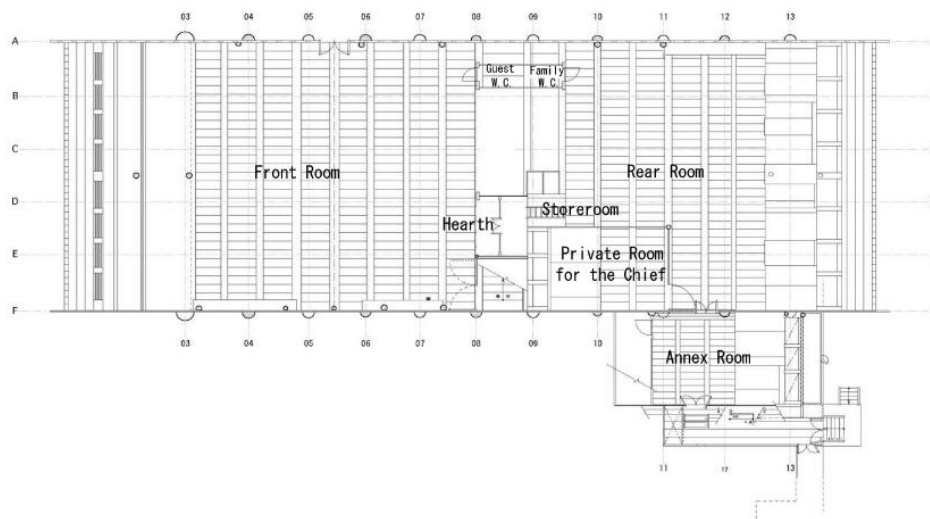
Figure 10. The plan of the second floor (1:200)

The second floor is used for daily life. The plan of the second floor is mainly composed by a front room (public) and a rear room (private, Figure 10). The front room is very spacious with no pillars. The area reaches 133 m<sup>2</sup>. It is an open space, used for guests and visitors, and the villagers can also enter it freely. At the front, there is a large trellis window, and through the window people can see the street. The rear room is for the chief family's private life. There is a hearth and a 5 m×3 m scale private room for the chief, arranged with a staircase. In addition, there is a private room for the chief's wife, which is located on the third floor over the storeroom with a protruded window overlooking the spacious room. To the east of the rear room, there is an annex room that is 6.5 meter in the spanwise direction and 3.5 meter in the trabecular direction. The annex room connects another independent room via a vestibule. This room was built several years later than the *omo sebua*, serving as a living space of the *omo sebua*. Its structure, is composed by many thin side pillars, which are about 20 cm in diameter, standing on both sides of the second floor, supporting the walls and the roof frame. The central side pillar on each side is made of two joint woods and directly supports the ridge.

The major damages of the main structure are the inclination of the side pillars and the uneven settlement of the floor. All the side pillars inclined to the center of the spacious room. The maximum inclination is 4/100 and the minimum inclination is 2/100, whilst even the minimum one should be considered serious. The uneven settlement resulted in a bent shape of the floor with the central part of the floor is higher than the marginal part, and the marginal part seems to be falling (Figure 11). The maximum sinkage is near the eastern staircase, which has already reached 17 cm. The same situation can also be seen in the family bedroom, the sinkage of which is 10 cm. The reason for the uneven settlement of the floor is considered to be connected with the damages of the substructure, and there seems a connection between the inclination of the pillars and the uneven settlement of the floor. This causal link cannot be well understood just by visual inspection.

Termite damage has spread to the walls and all construction elements and it is extremely significant at the back of the family bedroom. Besides, termites are obviously still inhabiting the building because the damages can be seen in the recently replaced components.

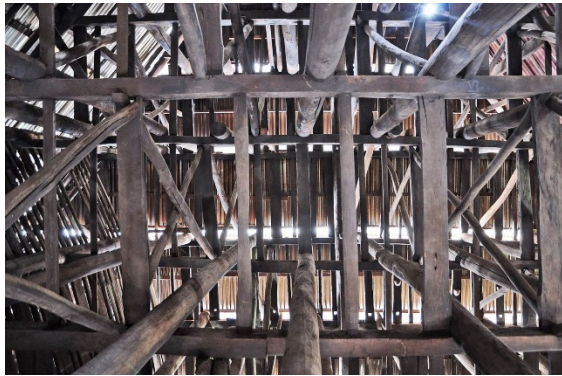
Figure 12. The roof frame

The roof frame is supported by the wooden walls as well as the side pillars. Twenty-four crossbeams are bridged across the tie beam with an interval of 1 meter. There are the struts standing above them. The huge roof frame consists of 9 piled up collar beam- and-strut groups, which eventually raises the ridge beam 23 meters from the ground (Figure 12). The tie beam is 7 cm in width and 53 cm in length, and it is shaped in a unique form by the dilated middle part. The collar beam is 40 cm in diameter. There are two types of struts. One type is 20 cm in width and 3 cm in thickness and the other type is 8 cm in width and 3 cm in thickness. The two types are set up alternately with an interval of 30 cm. Besides, there are round poles, 6-10 cm in diameter, used as struts and installed cross multiply in the transverse direction.

The corruptions of the roof frame concentrate on the gable wall, and they are caused by the rain penetration through the wide gable (Figure 13). Although the gable is covered by sago palm panels, the flashing is not thorough, and, easily damaged. In addition, a part of the sheet-metal roofing has been pried loose by wind, which caused the leakage and brought the corruptions. The other parts of the roof frame are relatively sound, but there is a high possibility that termite damages are occurring in the roof frame above the spacious room, because 3~4 beams have been replaced by new materials.

The great earthquake occurred in Sumatra caused significant damages to the roof frame and its elements. It loosened the roof frame and caused the cracks, which intensified the leakage and corruptions. Therefore, the *omo sebua* demands an urgent restoration.

For example, we suggest that the roofing of the *omo sebua* should be rethatched by sago palm leaf. In addition to the authenticity of the building, there is another significant reason for restoring the sago palm leaf roofing. It is that the temperature and humidity change in the roof frame doubles when it is covered by a metal panel instead of sago palm leaf. The dramatic change of temperature and humidity led to the acceleration of the decay of the roof frame (Sadaka, Uekita, T. Hanazato, Nitto, S. Hanazato, Ono and S. Hanazato, 2013; T. Hanazato, Uekita, Ono, Nitto and Oodaira, 2014), so restoring the roofing will help to restrain the decay. However, sago palm tree is not being produced anymore in South Nias because of the changes in the eating and drinking habits of the local people. Therefore, in order to get the roofing materials for the *omo sebua*, sago palm trees need to be planted.
