Study on Patch Bonding for Recovery of Damaged Carbon Fiber Reinforced Thermoplastics by Four-Point Bending Method

Keywords: CFRTP, patch bonding, fracture morphology, four point bending, laminate beam model

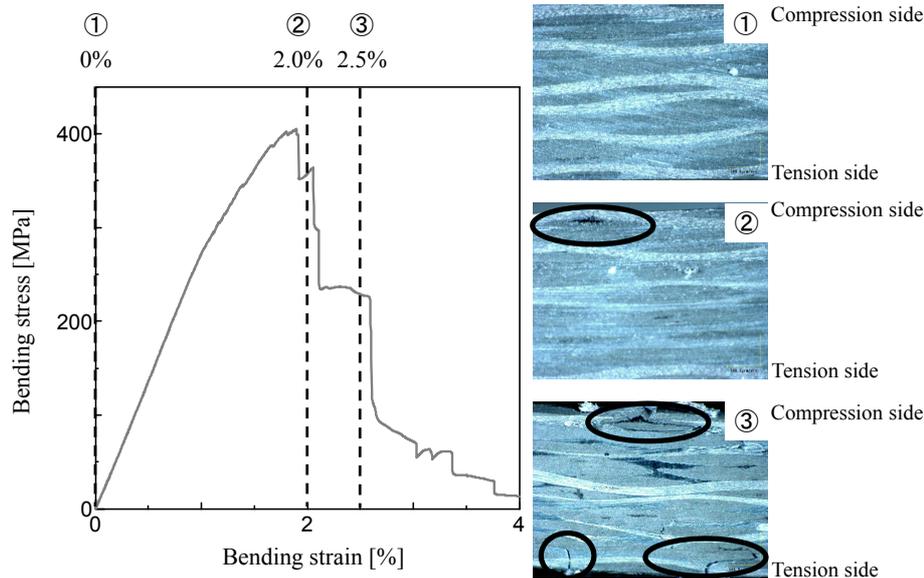
Figure 1. Typical stress-strain (S-S) diagram and side views of the specimen

Figure 1 shows the corresponding stress-strain (S-S) diagram during the four-point bending test and the side views of the specimen at different bending strains. Local delamination appeared first at 2.0% of the applied bending strain. When a bending strain of 2.5% was applied, fiber structure damage due to local buckling was observed at the compression side of the specimen. In order to investigate the damage of each carbon cloth at different bending strains, six specimens were prepared in which the applied bending strain was varied in steps of

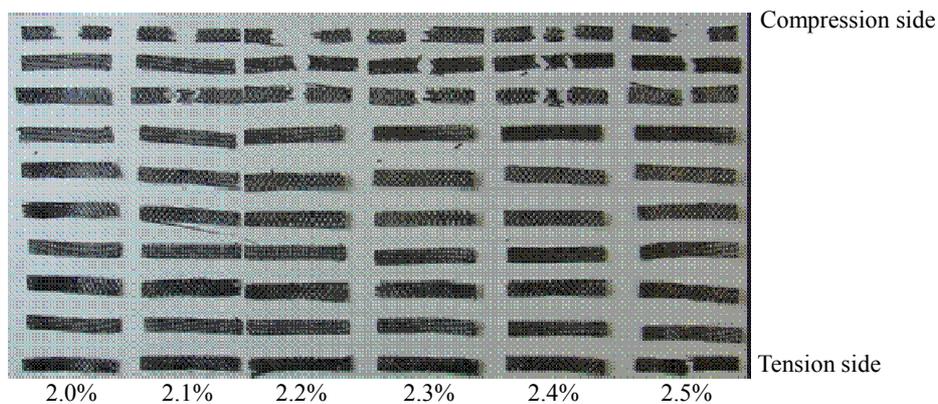
Figure 2. Damage state of each layer at different bending strains

0.1% from 2.0% to 2.5%. These specimens were heated at 400 °C for 120 min to extract the carbon cloths. The damage of each layer at different bending strains is shown in Figure 2. When 2.0% bending strain was applied, failure of the outer laminate of 0°–90° cloth at the compression side was confirmed. Using the incremental increase of the bending strain, it was found that failure of the carbon cloth initiated from the outer layer at the compression side and propagated up to the third layer of the 0°–90° cloth. When the bending strain reached 2.5%, failure of the carbon cloth was observed not only at the compression side, but also at the tension side. Therefore, in this study, the damage state of the specimens was divided into two classes: moderately damaged (bending strain $\varepsilon_b = 2.0\%$) and severely damaged ($\varepsilon_b = 2.5\%$).

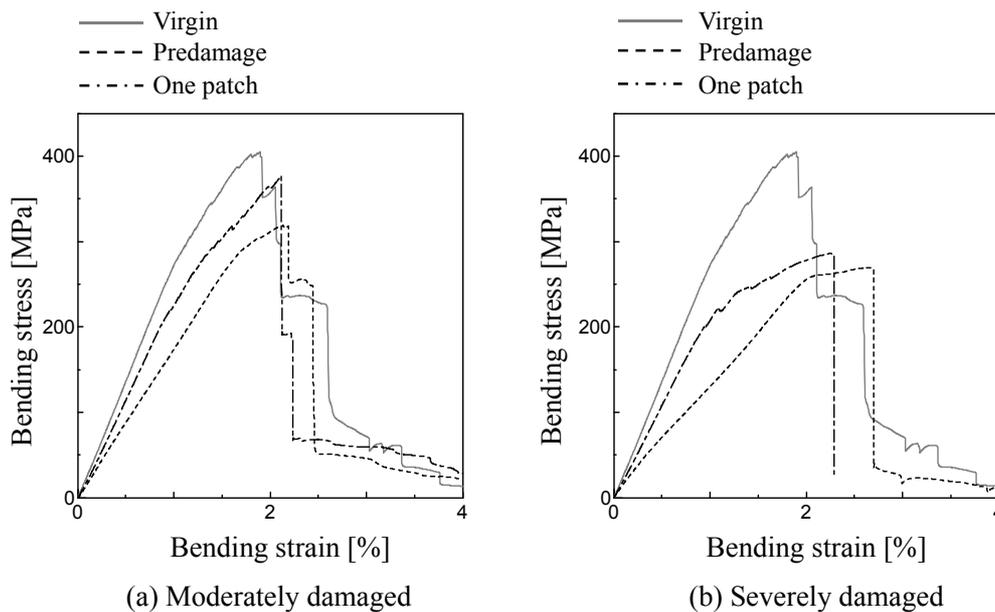
Figure 3. Typical stress-strain (S–S) diagrams of moderately (left) and severely (right) damaged samples

In this study, two types of predamaged specimens (“moderately” damaged and “severely” damaged) were prepared to investigate the effect of patch bonding on its bending characteristics. Figure 3 shows the bending S-S diagrams of virgin, predamaged, and repaired (one patch bonded at the compression side) specimens, respectively. The test results show that the bending characteristics of the predamaged specimens were degraded in comparison of the virgin samples. A recovery of the bending characteristics by patch bonding is also confirmed. To discuss the effect of repair by patch bonding, the normalized bending strength and the normalized

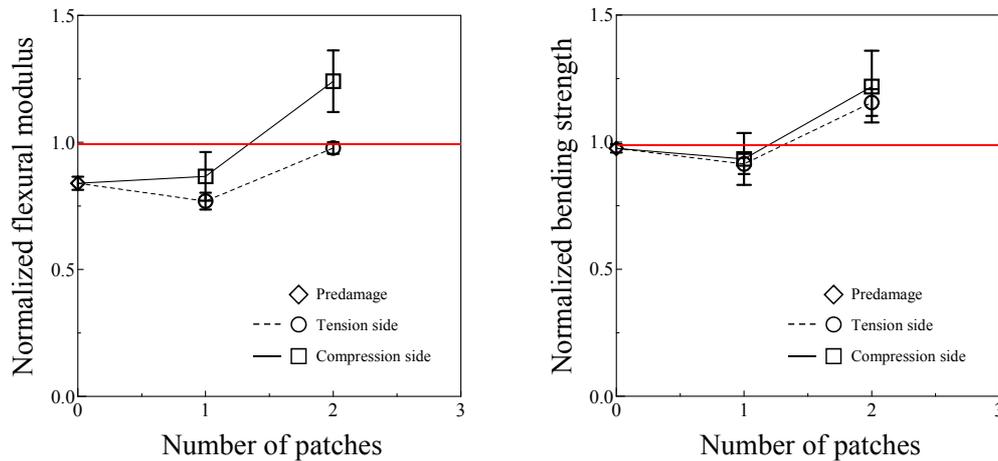
Figure 4. Repair results of moderately damaged specimens ($\epsilon_b = 2.0\%$)

In this study, the number of patches for repairing a damaged specimen was increased until the normalized bending strength and normalized flexural modulus exceeded 1.0. Figures 4 and 5 show the normalized bending strength and normalized flexural modulus of moderately and severely damaged specimens, respectively, repaired by patch bonding. The test results show that in case of a moderate damage, the bending strength and flexural modulus were recovered to value of the virgin specimen by at least two layers of patch bonding at either tension or compression side. On the other hand, in case of severe damage, at least three layers of patch bonding were required to fully recover the bending strength and flexural modulus. The test results also suggest that for the recovery of the bending characteristics, patch bonding at the compression side is more effective than at the tension side.

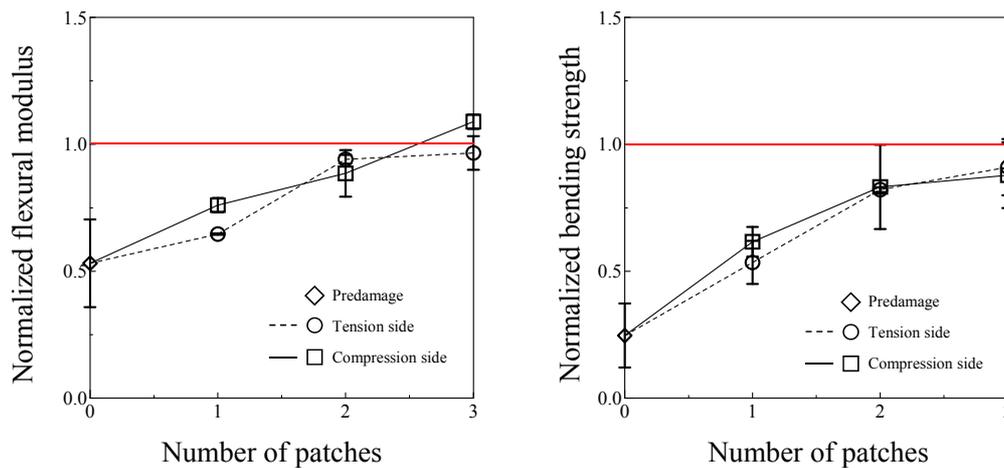
Figure 5. Repair results of severely damaged specimens ($\epsilon_b = 2.5\%$)

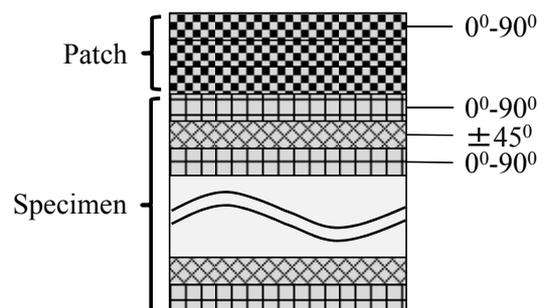
Figure 6. Schematic profile of a repaired sample used for model calculations

In order to evaluate the flexural modulus of repaired specimens, the CFRTP was modeled on the basis of laminate beam theory. To represent the actual damage state of the CFRTP (discussed in Section 3.1), the flexural modulus of the damaged laminate differs from the undamaged one. Table 3 lists the flexural modulus for the calculation and Figure 6 gives a schematic illustration of the patch-bonded CFRTP. Here, the value of flexural modulus were measured by model specimens, in which laminate configurations were $[0^\circ-90^\circ]_{10}$ and $[\pm 45^\circ]_{10}$, respectively.

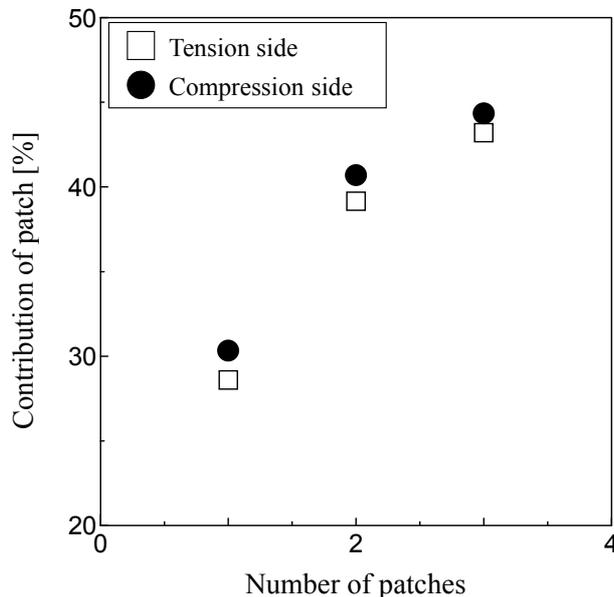
Figure 7. Relationship between the contribution of patch and the number of patches

Here, $\Sigma E_i I_i$, $\Sigma E_o I_o$, and $\Sigma E_p I_p$ denote the bending stiffness of the repaired specimen, damaged sample, and the bonded patch, respectively. In order to quantitatively discuss the effect of patch bonding on the stiffness of a repaired specimen, the contribution of a patch is parameterized by the ratio of the bending stiffness of the bonded patch to the bending stiffness of the repaired specimen, i.e., $\Sigma E_p I_p / \Sigma E_i I_i$. Figure 7 shows the relationship between this stiffness ratio and the number of bonded patch. When the number of patches was increased, the patch contribution to the bending stiffness also increased. Moreover, for the same number of bonded patches, their contribution to the bending stiffness was higher at the compression side than at the tension side.

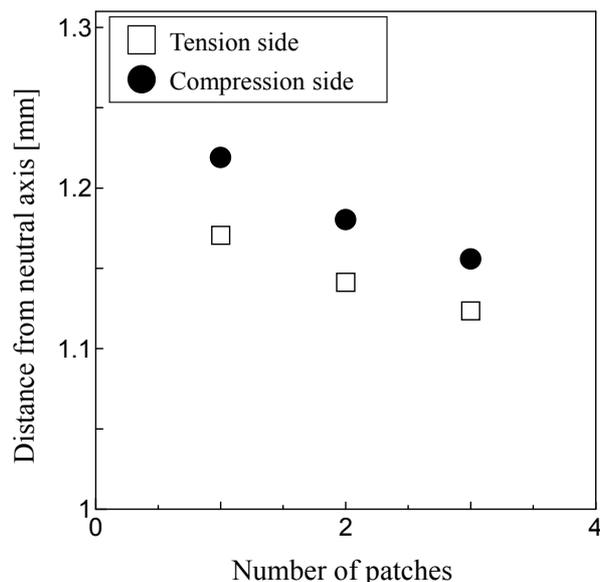
Figure 8. Relationship between the distance from the neutral axis and the number of patches

To explain why the contribution of a patch bonded at the compression side was higher than that at the tension side, the distance between the neutral axis and the outer laminate of a bonded patch was calculated. Figure 8 shows the relationship between the distance from the neutral axis and the number of patches. The distance from the neutral axis to a bonded patch at the compression side is longer than that at the tension side. This result suggests that the moment of inertia per area of the bonded patch at the compression side would be higher than that at the tension side. Therefore, patch bonding at the compression side is more effective than at the tension side. These results also suggest that in order to improve the reparability of patch bonding, the distance between neutral axis and the patch should be longer.
