Decontamination of Mercury Contaminated Steel (API 5L-X52) Using Iodine and Iodide Lixiviant

Investigations assessed the surface chemistry, morphology and depth profile of Hg for gas processing pipe steel coupons of API 5L-X52 after adsorption with elemental Hg at 25 °C in the presence of air. We investigated the effect of Hg adsorption periods and surface Hg levels as well as characterizations of Hg depth profiles. We observed no reasonable correlation between surface Hg levels and Hg adsorption periods. Forms of Hg found on the top surface and in the depth profile were in oxide and elemental forms, respectively. However, most of the Hg present was superficial and did not penetrate below the surface significantly. The lowest concentration lixiviant, with 0.2 Molar iodine and 2.0 Molar potassium iodide, worked well with all ranges of Hg contamination observed, with the final surface Hg levels of less than 0.1 atom% by XPS analysis, for a relative percentage of Hg removal about 99%.

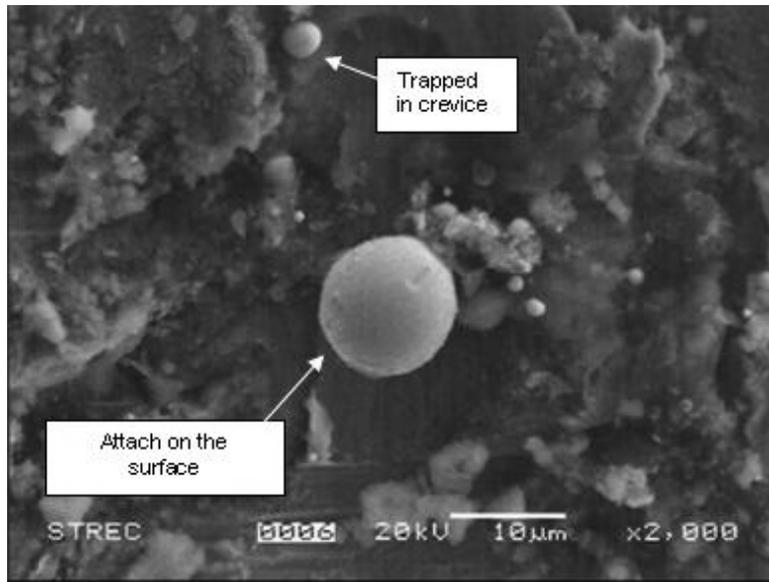
Figure 1. Spherical Hg^0 droplets are present on the metal coupon surface following adsorption

Illustrations from SEM, as shown in Fig. 1, revealed mercury as spherical droplets of various sizes on the coupon surface. The larger droplets could be greater than 10 μm in diameter, whereas the smaller ones could be less than 1 μm. Surface distribution of the Hg droplets was irregular with respect to both adsorption site and droplet size.

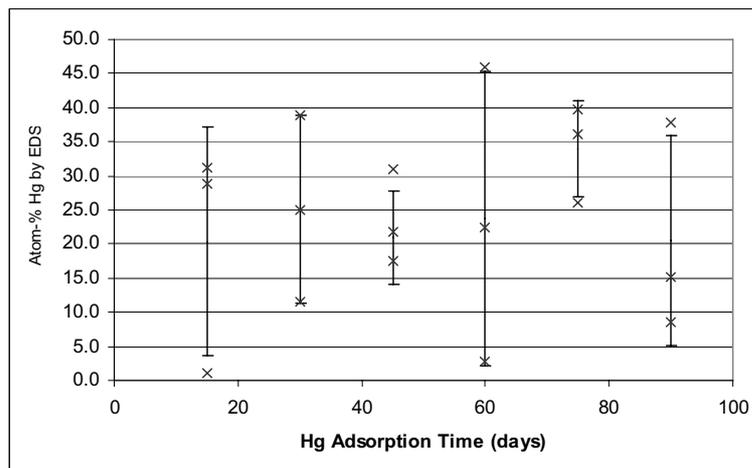
Figure 2. Surface Hg concentrations at the end of each Hg adsorption period using EDX analysis

Fig. 2 presents the results of surface Hg analysis using EDX at the end of each Hg⁰ adsorption period, and shows that the surface Hg levels range from less than 5 to 45 atom%. However, analysis of surface Hg levels using XPS analysis two weeks after the end of each Hg⁰ adsorption period showed much lower surface Hg concentrations, ranging from less than 0.5 to about 3.0 atom%. We found no reasonable correlation between the surface Hg levels and the adsorption periods for either of the surface analysis techniques used. Fig. 3 shows surface Hg levels at the end of each Hg adsorption period by XPS analysis.

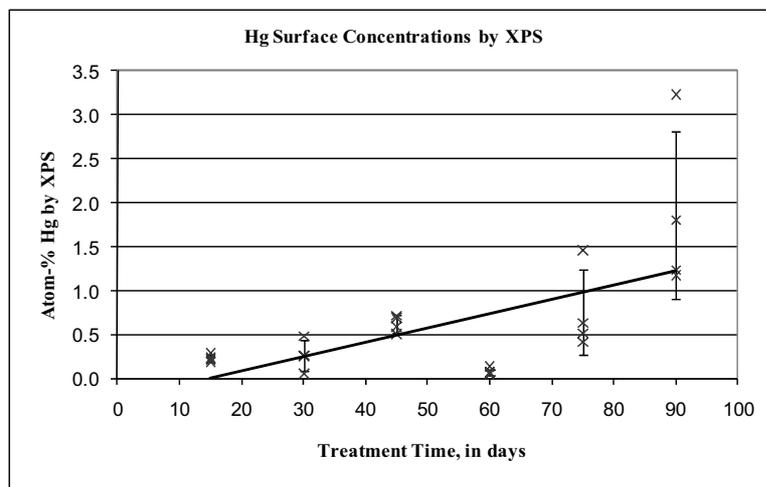
Figure 3. Surface Hg levels by XPS analysis at the end of each Hg^0 adsorption period

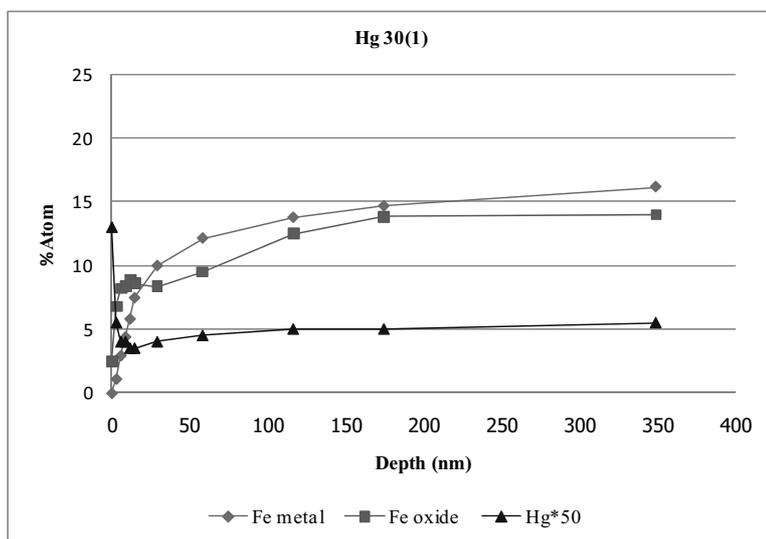
Figure 4. Hg in the depth profile of the 30 day Hg⁰ adsorption coupon

The Hg concentration depth profiles showed that most Hg was present within the short depth of only about 10 nm from the topmost surface. The levels of Hg in the depth profile were low, mostly below 0.1 atom%. Therefore, Hg is present on the surface only and does not penetrate significantly into the depth. A previous study of field samples of gas processing pipe collected in a gas field of Northern Germany also with naturally-occurring mercury reported a similar finding. This previous study indicated that mercury is only adsorbed on the steel surface and did not penetrate into the depth (Zettlitzer and Kleinitz, 1997). Figs. 4 through 6 show Hg levels in the depth profile at the end of 30, 75 and 90 day of Hg^0 adsorption, respectively. Note that Hg levels in these figures are multiplied by 50 to better match the scale of other elements' concentrations.

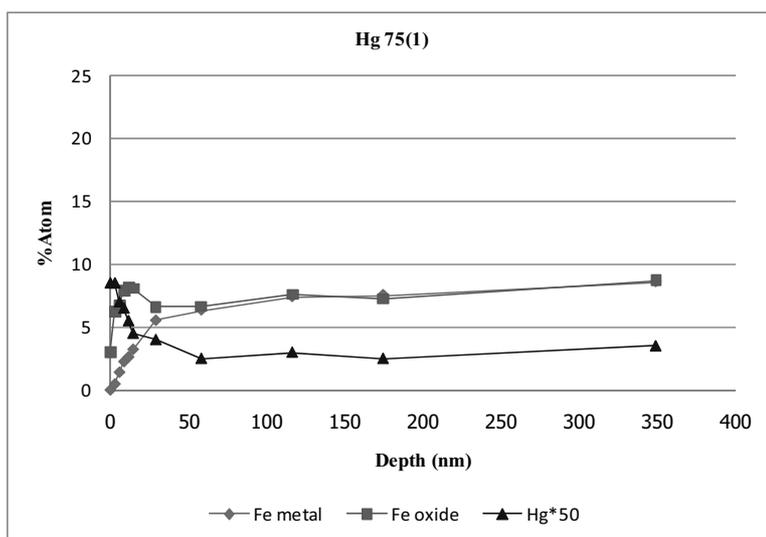
Figure 5. Hg in the depth profile of the 75 day Hg⁰ adsorption coupon

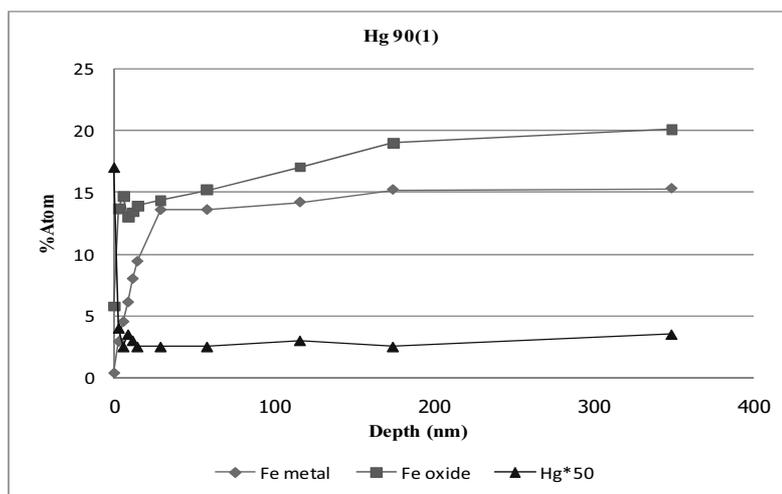
Figure 6. Hg in the depth profile of the 90 day Hg⁰ adsorption coupon

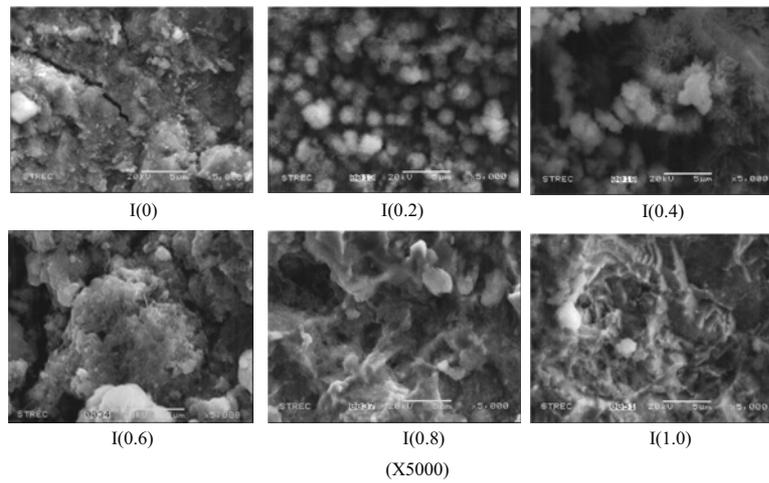
Figure 7. Surface morphology of the 30 day Hg^0 adsorption coupons after lixivient treatment
The concentration of iodine, ranging from 0 Molar to 1.0 Molar, is listed below the corresponding micrograph

Surface morphology of steel coupons after the mercury decontamination of 30, 75 and 90 days of Hg^0 adsorption is shown in Figs. 8 through 10, respectively. The post-decontamination surface morphology showed no droplets of elemental mercury. We also found that with higher iodine concentrations, more surface corrosion occurred. These observations are consistent with iodine as an oxidizing agent that not only oxidized Hg present on the top surface, but also corroded the steel surface allowing contact with any small amount of Hg below the surface. Therefore further investigation of Hg in the depth profile after the decontamination is deemed unnecessary.

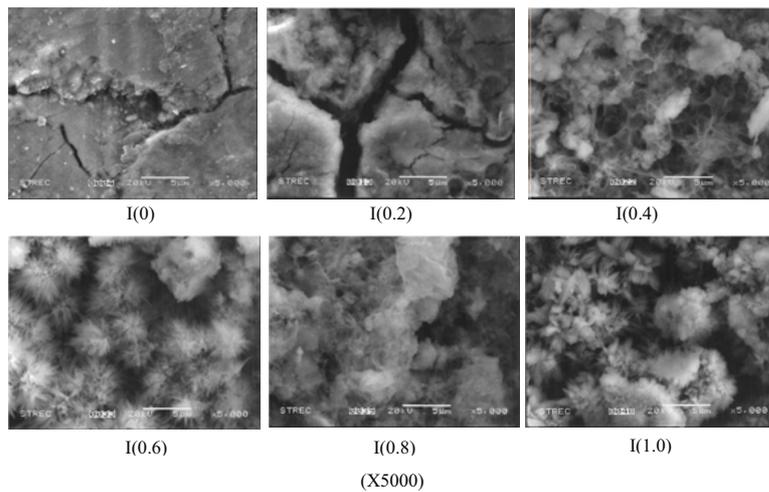
Figure 8. Surface morphology of the 75 day Hg^0 adsorption coupons after lixivient treatment
The concentration of iodine, ranging from 0 Molar to 1.0 Molar, is listed below the corresponding micrograph

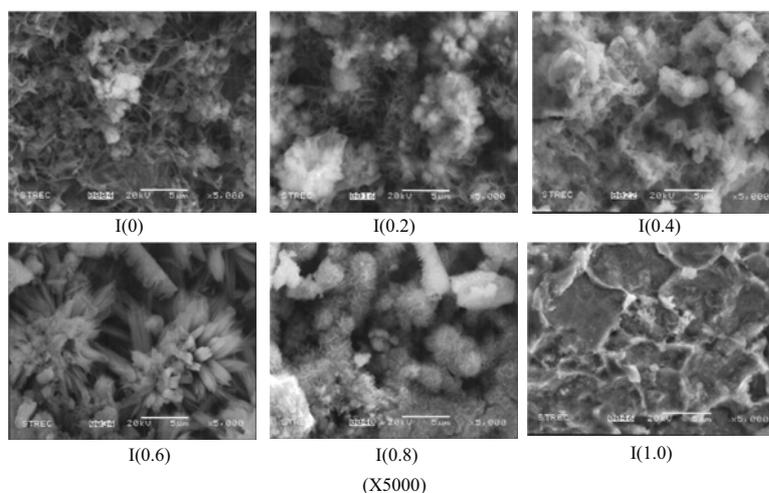
Figure 9. Surface morphology of the 90 day Hg^0 adsorption coupons after lixivient treatment
The concentration of iodine, ranging from 0 Molar to 1.0 Molar, is listed below the corresponding micrograph

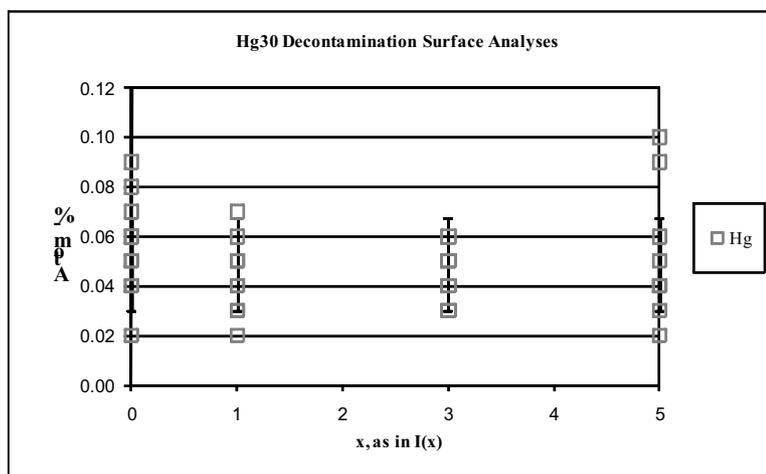
Note I(0) = no iodine, I(1) = 0.2 Molar, I(3) = 0.6 Molar and I(5) = 1.0 Molar

Figure 10. Hg surface concentration by XPS of 30 day Hg adsorption coupons following lixivient treatment with various concentrations of iodine and 2.0 Molar iodide

The EDX analysis of the coupon surfaces after the decontamination of 30, 75 and 90 day Hg^0 adsorption showed no mercury present. Note that the detection limit of the employed EDX is less than 1 atom% Hg. However, the XPS analysis, with its lower surface detection limit, revealed the maximum levels of mercury on the coupon surfaces after the decontamination of 30, 75 and 90 day Hg^0 adsorption of 0.1, 0.19 and 0.14 % atom, respectively, at various iodine concentrations. We present these data in Figs. 10 through 12.

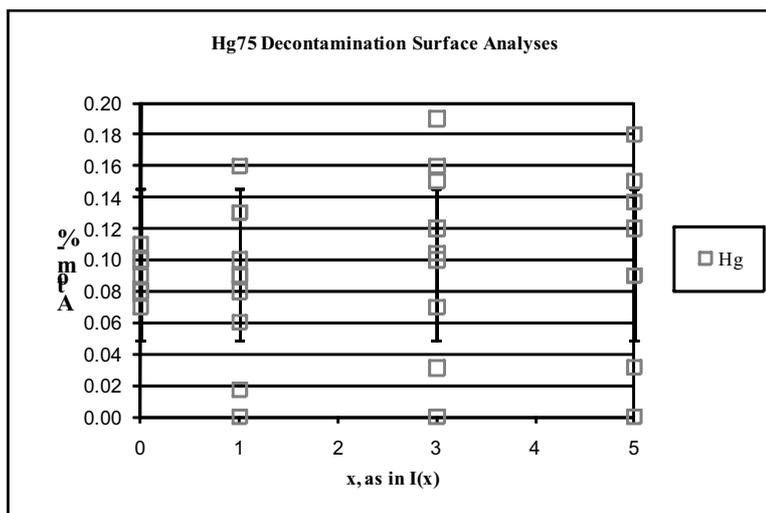
Note I(0) = no iodine, I(1) = 0.2 Molar, I(3) = 0.6 Molar and I(5) = 1.0 Molar

Figure 11. Hg surface concentration by XPS of 75 day Hg adsorption coupons following lixivient treatment with various concentrations of iodine and 2.0 Molar iodide

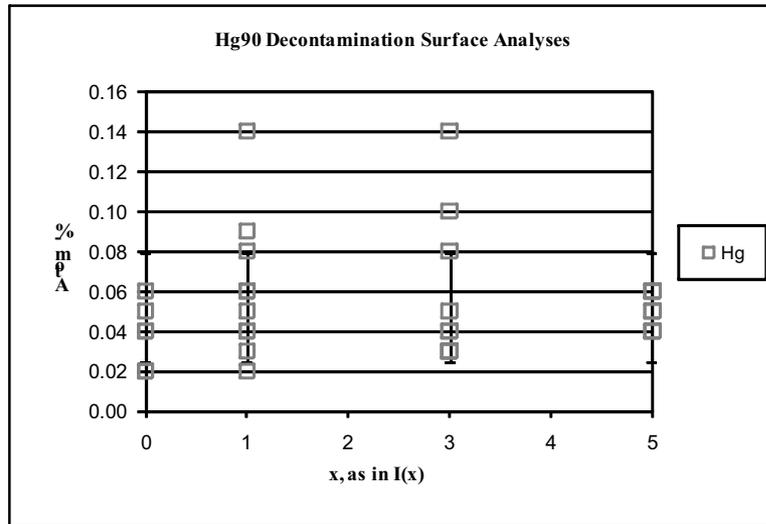
Note I(0) = no iodine, I(1) = 0.2 Molar, I(3) = 0.6 Molar and I(5) = 1.0 Molar

Figure 12. Hg surface concentration by XPS of 90 day Hg adsorption coupons following lixiviant treatment with various concentrations of iodine and 2.0 Molar iodide

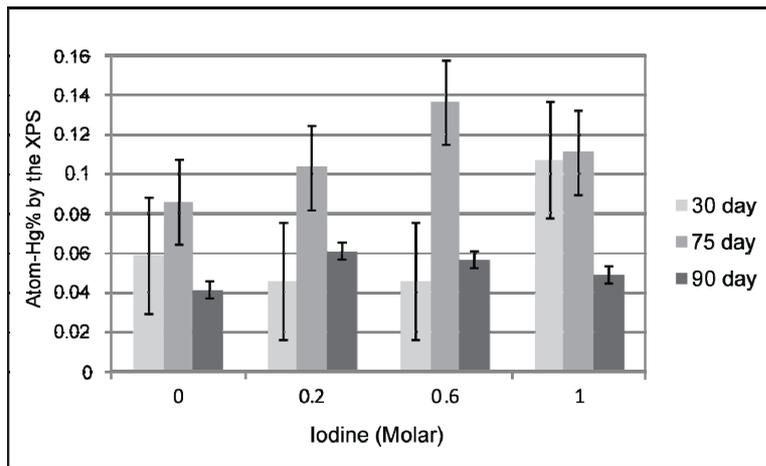
Figure 13. Surface Hg levels in atom% by XPS of steel coupons after the decontamination treatment

Fig. 13 plots the percentage of Hg removed by the decontamination of 30, 75 and 90 day Hg^0 adsorption coupons using various concentrations of iodine between 0 and 1.0 Molar with a constant concentration of potassium iodide (2.0 Molar). These data demonstrate that there was no significant difference, in terms of surface Hg removal, among the various concentrations of iodine used, including with no iodine. As mentioned earlier, iodine is required to oxidize elemental mercury present on or just below the surface. As a result, we find 0.2 Molar iodine is the lowest iodine concentration that should be used. Taking into account the surface Hg levels by the EDX analysis of about 40 atom% generally found in 30, 75 and 90 day Hg^0 adsorption samples and those of the same set after the decontamination with the maximum Hg levels of 0.1 atom% Hg by XPS, the relative percentage of Hg removal using iodine/iodide of 0.2/2.0 Molar is, therefore, more than 99%.
